CDB '80 1002

CUMBERLAND STEAM PLANT - ANNUAL ASH DISPOSAL AREA INSPECTION

EDB '80 1002 001

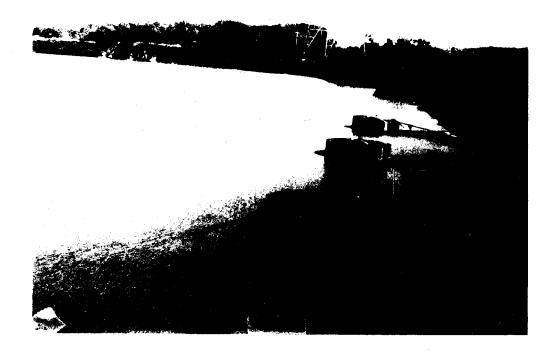
Standard spillways and skimmers. Note floating ash

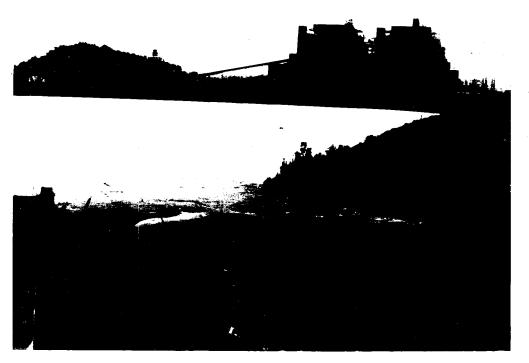
The floating skimmer in the divider dike was badly out of position (see picture 3) allowing floating fly ash to get into the stilling pool. The entire stilling pool area was covered with floating ash on the day of the inspection. According to plant employees, most of the floating ash entering the stilling pool builds up behind the skimmer causing the skimmer to sink. The floating ash then flows over the skimmer.

Spillway through divider dike. Skimmer is too high on each end, sunk in the middle.

- 1. Plant employees should continue to remove floating ash from the stilling pool as it accumulates.
- 2. Adjust the floating skimmer in the divider dike. Lower the channel approximately 2 feet if necessary to reduce the velocity of water flowing past the skimmer or raise the spillways 2 feet.
- 3. Seal all joints between timbers at wood barriers in divider dike with bituminous filler.
