CUMBERLAND FOSSIL PLANT (CUF) - INSPECTION OF WASTE DISPOSAL AREAS

August 5, 1994

CUMBERLAND FOSSIL PLANT - INSPECTION OF THE WASTE DISPOSAL AREAS

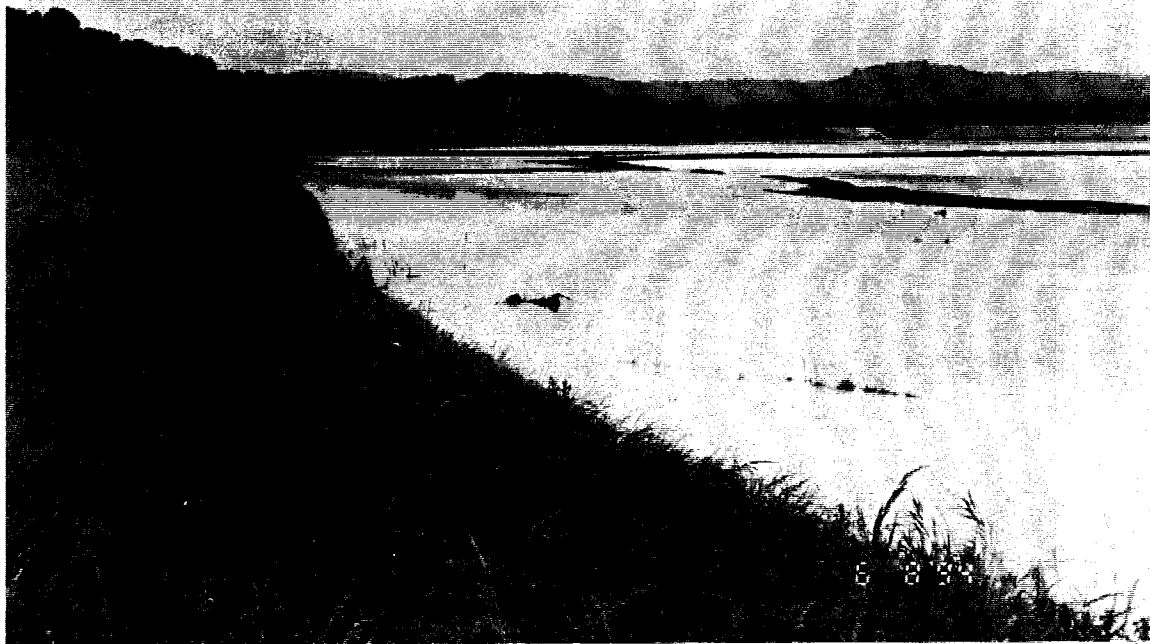
- 3.1.1 A new dike for the gypsum disposal area is being constructed in the eastern end of this area.
- 3.1.2 The pond level is currently being raised to elevation 384 to compensate for water storage that is being lost due to present and future construction.
- 3.1.3 A few small trees are beginning to grow on the interior dike slope in this area. These trees should be removed with their root structures to prevent future seepage or failures.
- 3.1.4 The areas of seepage along the Wells Creek Channel were not visible due to high water in the channel. Inspection revealed no signs of structural instability anywhere along the dike.
- 3.1.5 Vegetative cover was good on the dikes of this area (Figure 1).

Figure 1. Excellent vegetative cover on interior slope of dike in area no. 2.
Note small trees growing on interior.

- 6.1 All trees along the interior slopes of the dikes should be removed by pulling with a chain to remove their root systems. (Reference 3.1.3)
- 6.2 Remove the trees located on the slope above the outlet discharge pipes by pulling them. The vegetation should be kept cut here so that stability of the slope above the pipes can be monitored.
- 6.3 Continue to monitor the seepage areas, especially since the water level behind the dike is being raised (Reference 3.1.2). Report any problems to Site Engineering.

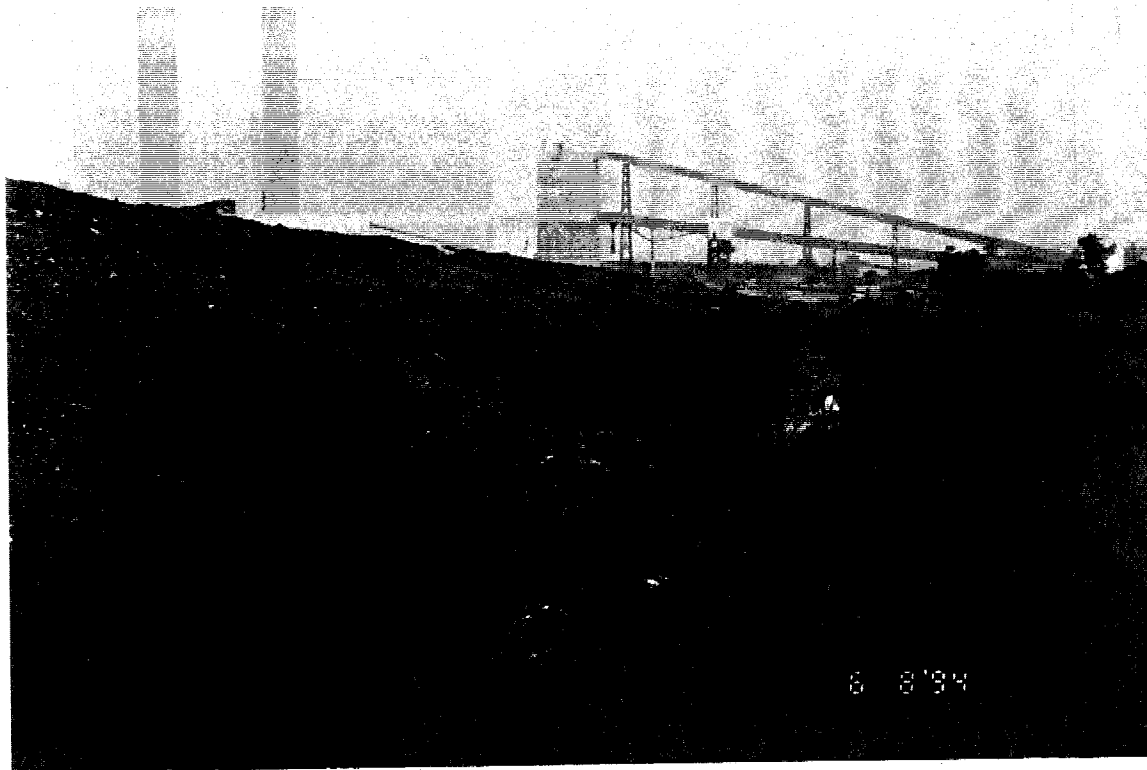
The dredge pond is full and has no water standing in it. A wet gypsum waste storage facility is currently being prepared in this area. A starter dike is being constructed to elevation 410 along the interior of and parallel to the northern, southern, and eastern perimeter dikes (Figure 2). The western boundary of the wet gypsum area will be defined by a starter dike which is currently being constructed to elevation 410 parallel to the eastern side of the 161 kV transmission line in area no. 2 (Figure 3).

Figure 2. Ditch separating starter dike for wet gypsum stack from perimeter dike in area no. 1

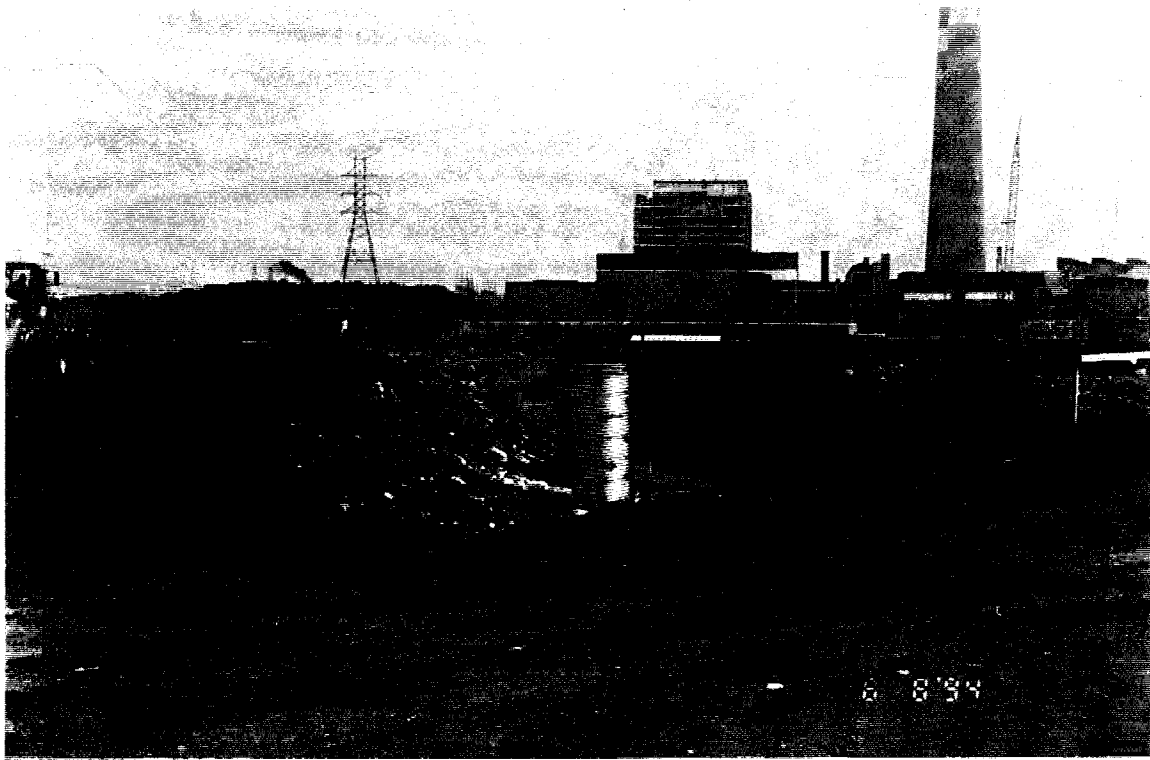
Figure 3. Construction of northern starter dike for wet gypsum stack.

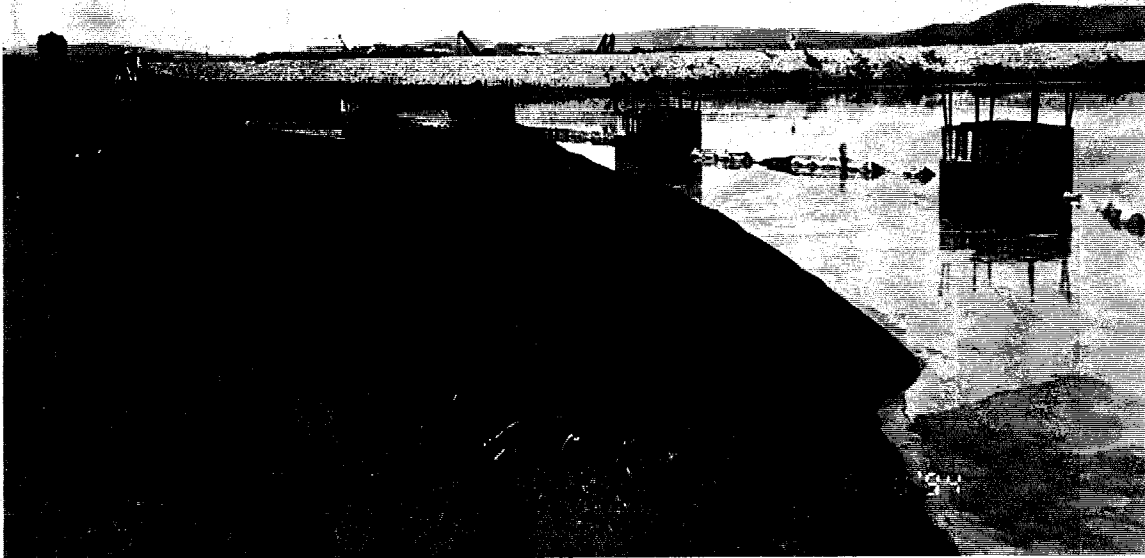
Figure 4. Spillways after being raised to elevation 378. Note the excellent riprap cover on the divider dike in the background.

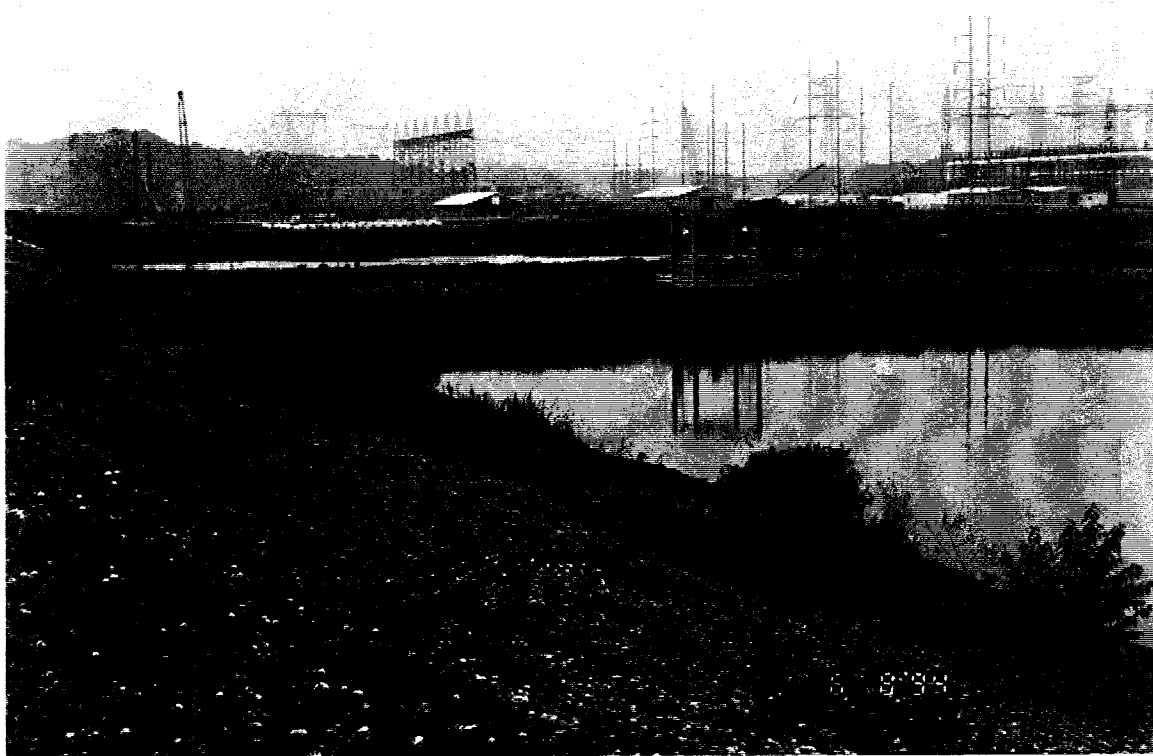
- 4.1 The chemical treatment pond for iron is located on the north side of the dike surrounding ash disposal area no. 1. The pond was constructed by excavating into the surrounding earth, so no exterior dike slope exists. The interior slope has an excellent cover of riprap (Figure 6).
- 4.2 The pond appeared structurally stable and free of debris. No maintenance was necessary at the time of the inspection.

- 5.1 The coal yard drainage basin is located on the north side of area no. 1 just west of the chemical treatment pond. It was also constructed by excavation into surrounding earth.
- 5.2 The interior slopes have a good cover of vegetation (Figure 6). The pond needs to be dredged to increase its capacity to normal.

Figure 6. Chemical treatment pond with excellent riprap cover on the dike slopes. Coal yard drainage basin is in background with good vegetative cover on the dike slopes
