March 28, 1995

CUMBERLAND FOSSIL PLANT (CUF) - INSPECTION OF WASTE DISPOSAL
AREAS

CUMBERLAND FOSSIL PLANT - INSPECTION OF THE WASTE DISPOSAL AREAS

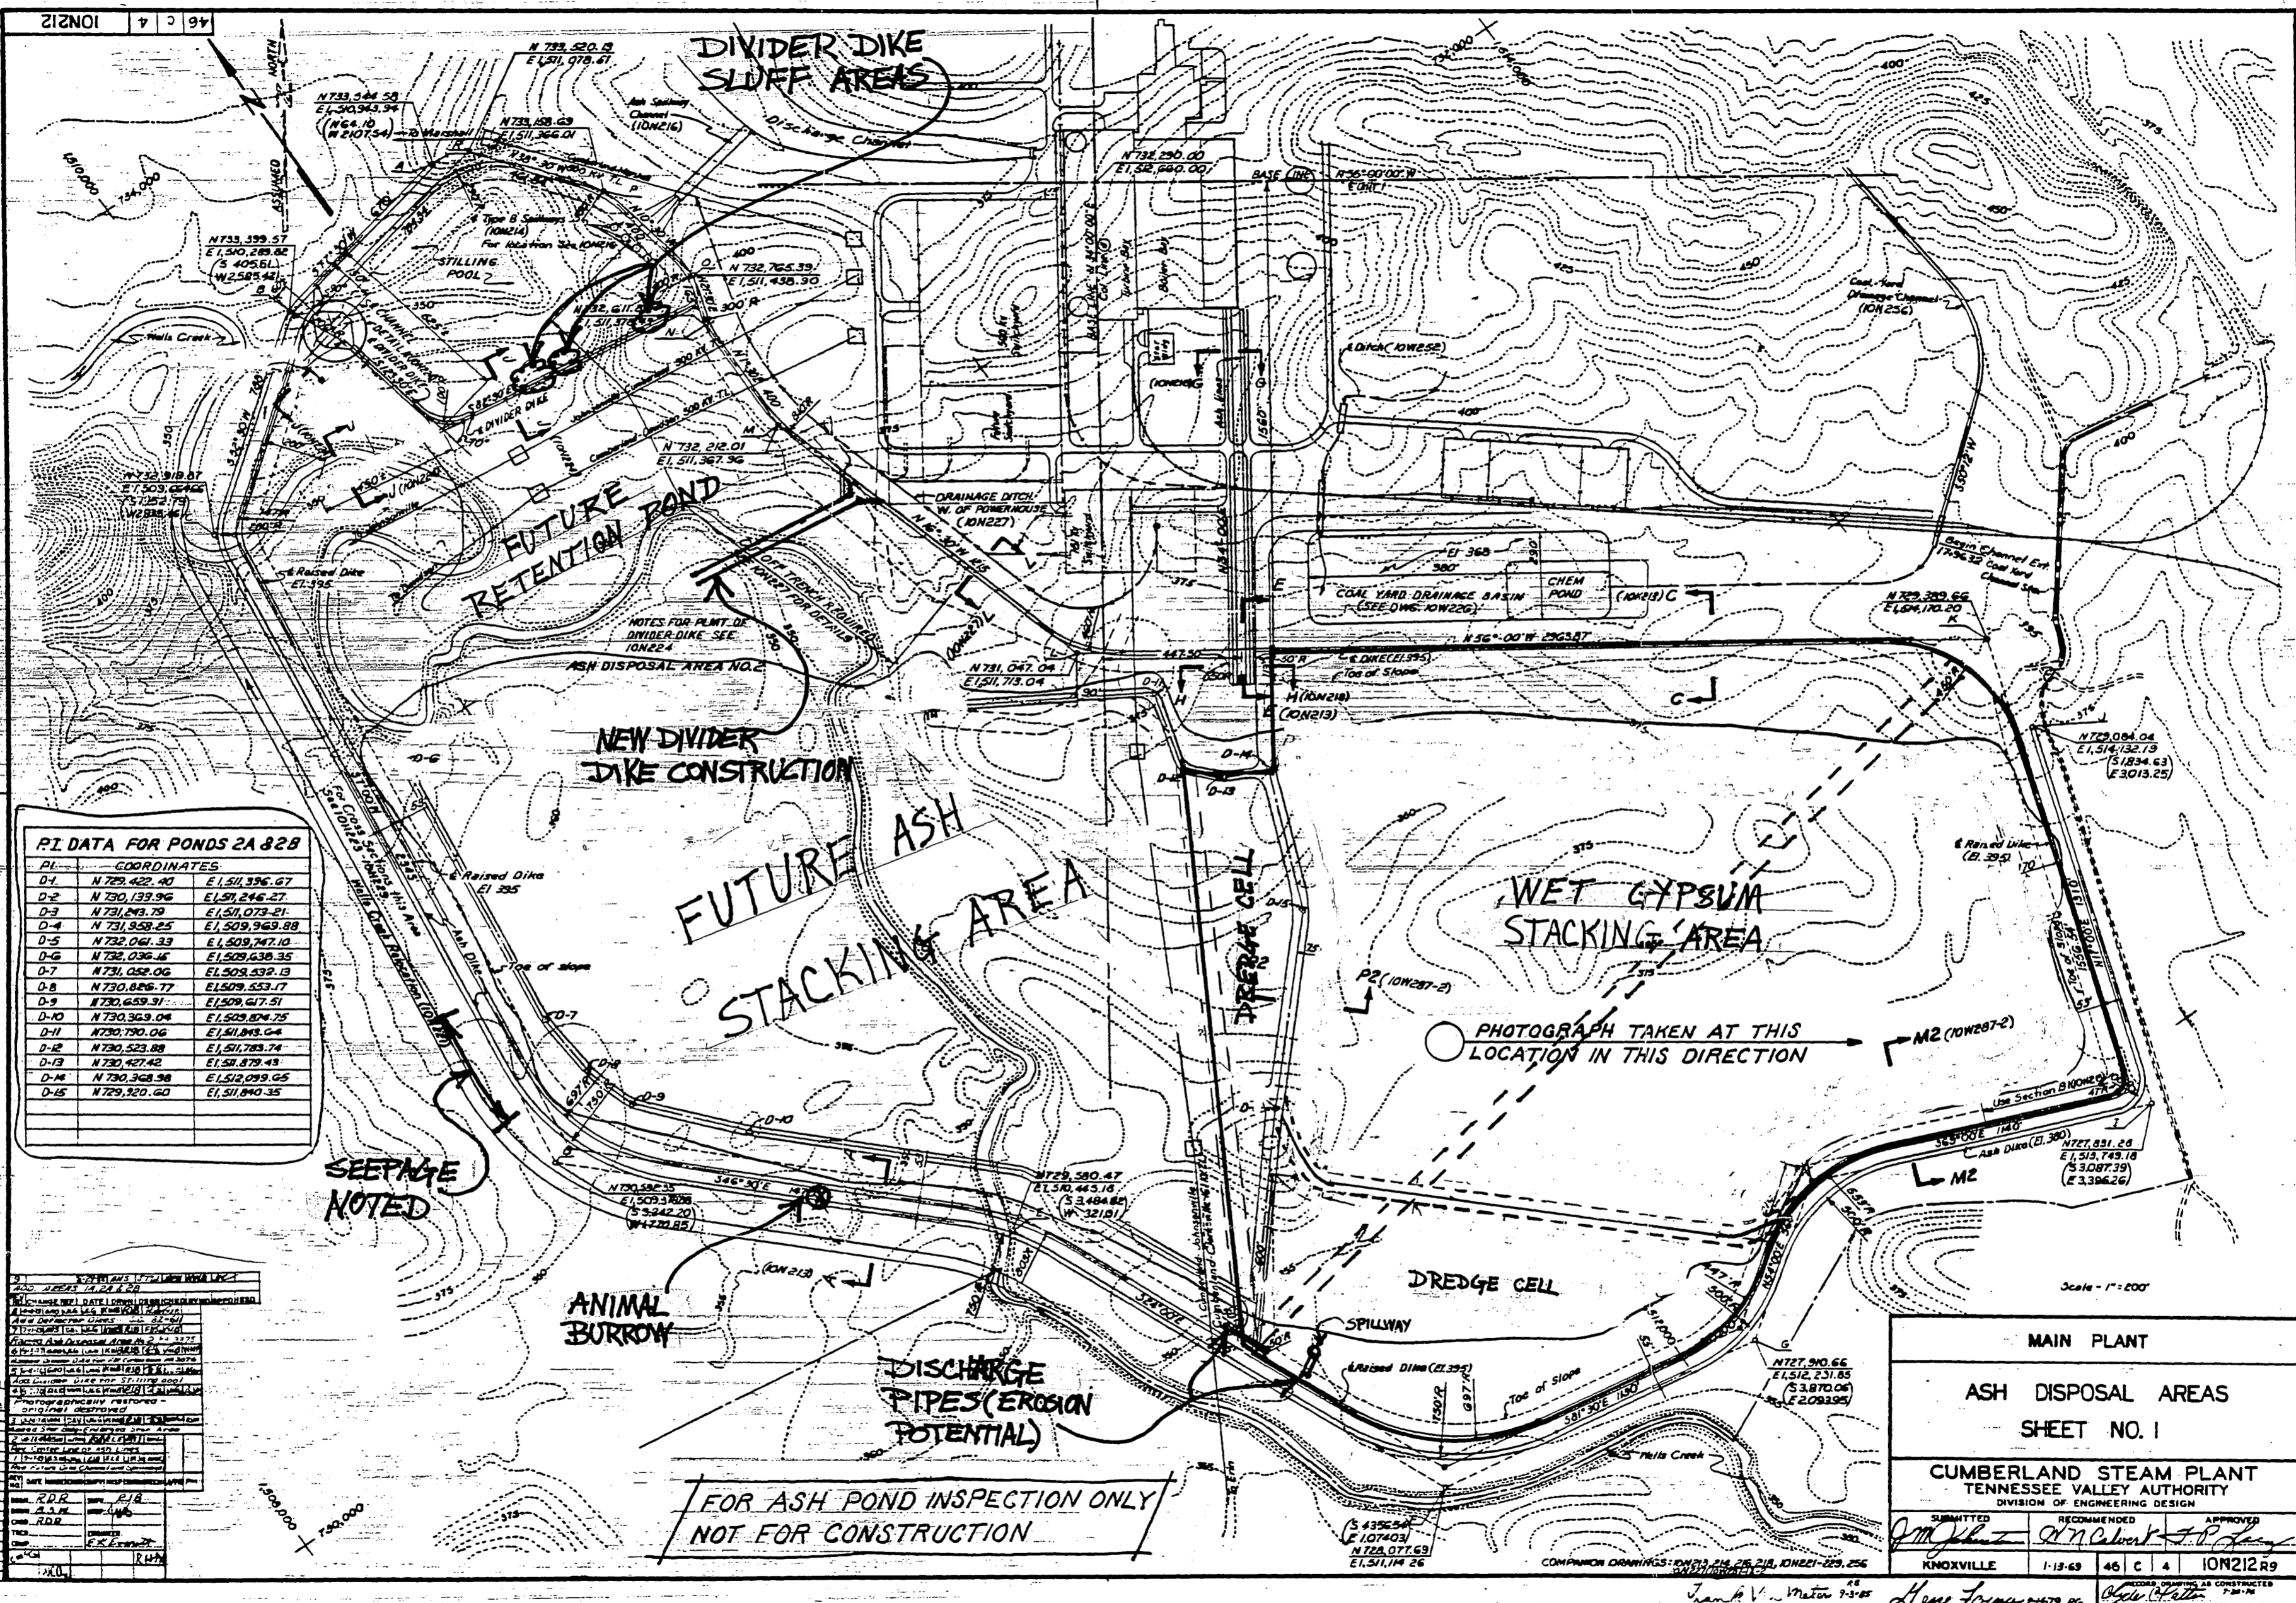
ASH DISPOSAL AREAS

- 1.1 This inspection of the waste disposal areas was conducted on March 15, 1995.
- 1.2 The last inspection was conducted on June 8, 1994.
- 1.3 This was a joint inspection by representatives of Fossil Fuels and Fossil Engineering (FE). The inspection was performed by Jim Huber, Fossil Fuels; Jerry Glover, FE; and Keith Elder, FE.
- 1.4 Our findings during this inspection were not discussed with plant personnel the day of the inspection due to completion late in the day. Jim Huber discussed our observations and recommendations with Jeff Cummings, Yard Operations Supervisor, and Gene Leslie, Heavy Equipment Foreman, the following day (March 16).
- 1.5 The areas referenced in the report are shown on the attached print of drawing 10N212.
