CUMBERLAND FOSSIL PLANT (CUF) - ANNUAL INSPECTION OF WASTE DISPOSAL AREAS

TENNESSEE VALLEY AUTHORITY
CUMBERLAND FOSSIL PLANT

*ANNUAL INSPECTION OF
WASTE DISPOSAL AREAS*

CUMBERLAND FOSSIL PLANT
NPDES PERMIT NO. TN0005789
ANNUAL ASH POND DIKE INSPECTION
1997

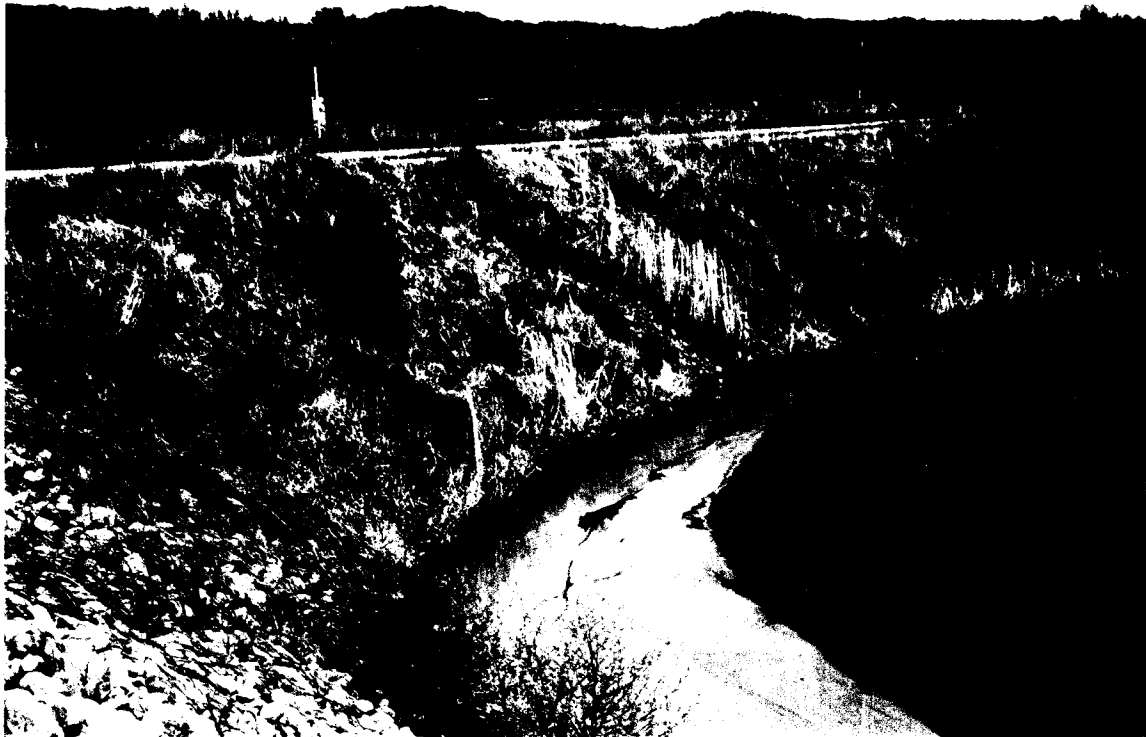
A small slide was noticed on the inside slope of the southeast corner of the stilling basin. This area should be monitored and repaired if the slide appears to worsen. Otherwise, the interior slopes in this area were in good condition with excellent vegetative cover.

Figure 1. Minor slide on interior slope of stilling basin.

Monitor the minor slide on the interior slope of the stilling basin (See Figure 1). If the area worsens, then backfill the area with earth material and cover with well graded crushed stone or riprap.
