CUMBERLAND FOSSIL PLANT (CUF) - ANNUAL INSPECTION OF WASTE
DISPOSAL AREAS

TENNESSEE VALLEY AUTHORITY
CUMBERLAND FOSSIL PLANT

*ANNUAL INSPECTION OF
WASTE DISPOSAL AREAS*

**CUMBERLAND FOSSIL PLANT
NPDES PERMIT NO. TN0005789
ANNUAL ASH POND DIKE INSPECTION
1998**

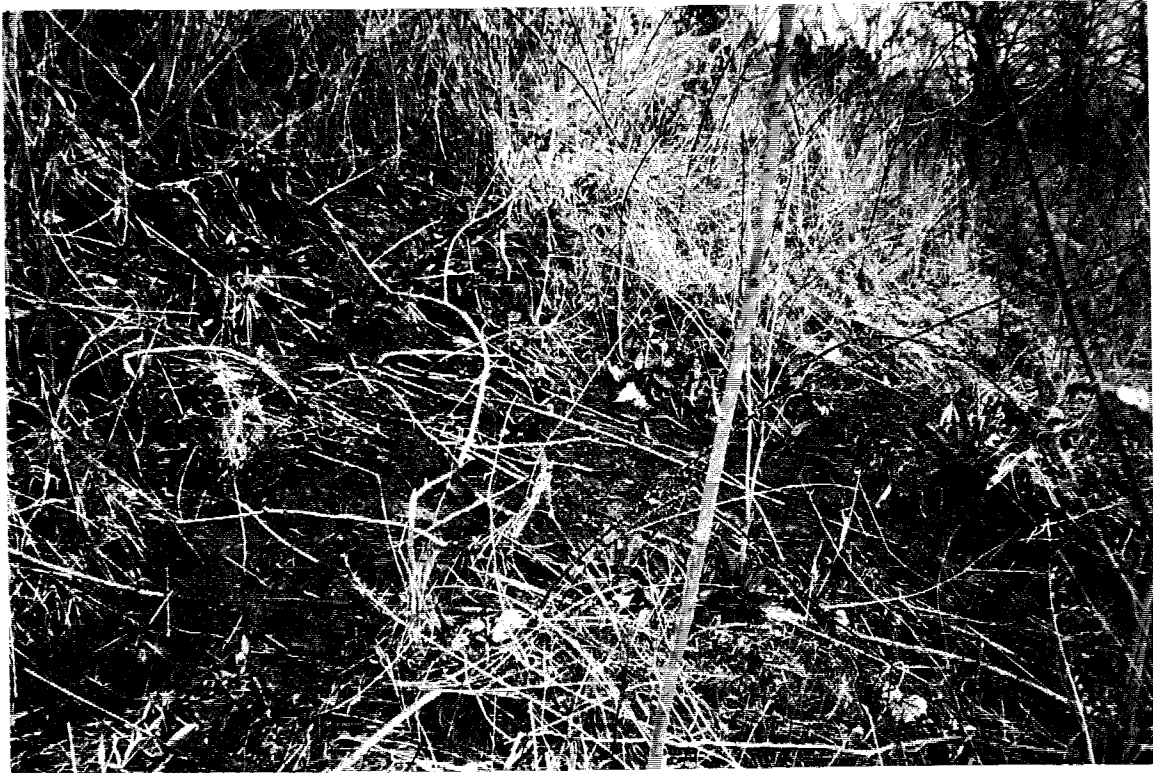
A new area of seepage was detected on the outer slope of the lower dike along the northeastern side of this area. The seep stretches approximately 75 feet along the dike and varies in width up to about 10 feet. No material movement was present, and the seep does not appear to pose a threat to the structural integrity of the dike at this time. Two more minor seeps (less than 4' diameter) were noted on the south dike, but these also pose no threat to dike integrity at present. Three animal burrows were noted in the toe of the northeast dike. One was active and two were inactive. Plant personnel were doing a fine job of removing trees along the south dike by pulling them and their roots from the ground. Some small disturbed areas were present due to this operation. The exterior slopes had excellent vegetative cover in all other areas around the exterior of the gypsum stacking area.

Figure 1. Seep area along eastern dike.

- Monitor the newly detected seeps along the eastern lower dike of the wet gypsum stacking area. Check for signs of material movement and increased seepage. Please notify Fossil Engineering if any significant changes are noticed.
- Repair the four animal burrows shown on sketch API98. These areas should be filled with clay material, tamped, and seeded. An animal trapper should be retained to capture the animal that is using the active burrow.

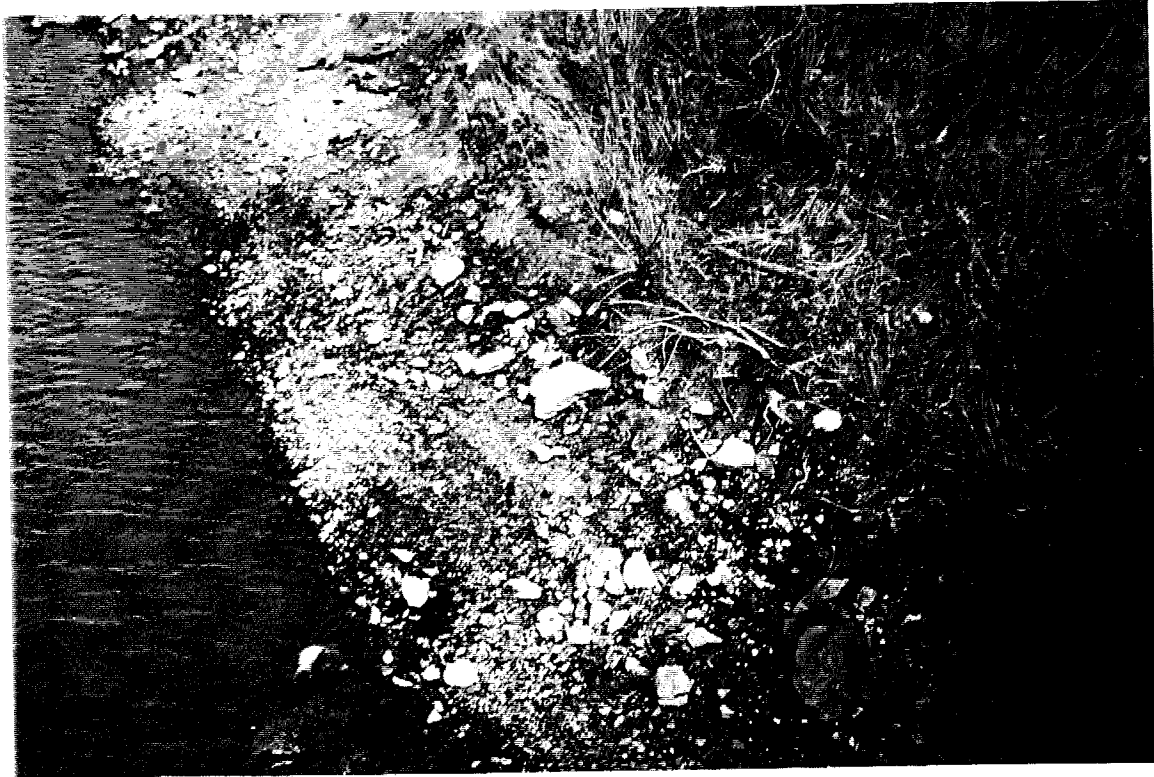
The previously identified areas of seepage near the construction bridge over Wells Creek were still present. The seeps appeared to have the same intensity as noted last year. A visible flow of water was noted coming from the seep directly under the bridge. Plant personnel were planning on lowering the water elevation in the pond from the present elevation of 384 ft to 380 ft to relieve some of the hydrostatic pressure over this area. This will have a positive effect on decreasing the seeps.

Figure 2. Seeps along bank of Wells Creek as seen from bridge.

- Continue to remove the trees growing on the slopes of the dikes. Seed and mulch any disturbed areas.
- Monitor the seeps along the bank of Wells Creek in the vicinity of the construction bridge. Please report any changes to Fossil Engineering.

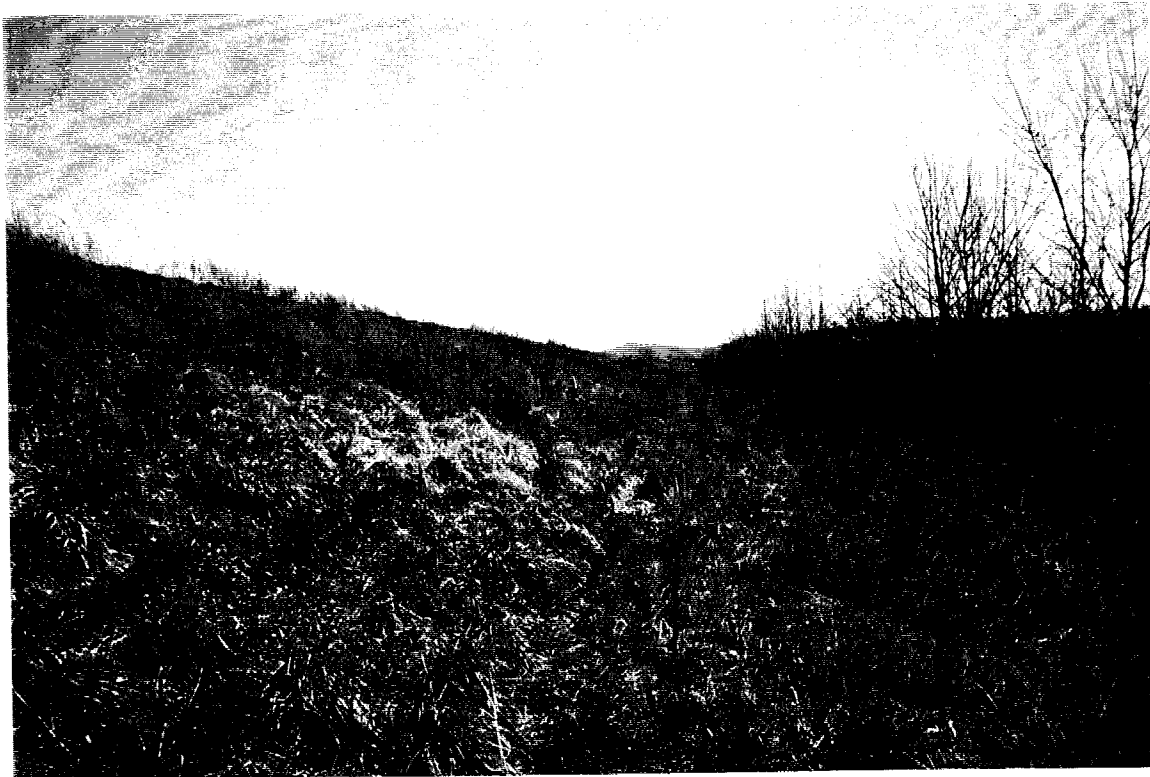
Figure 3. Southwestern dike in good condition with excellent vegetative cover.

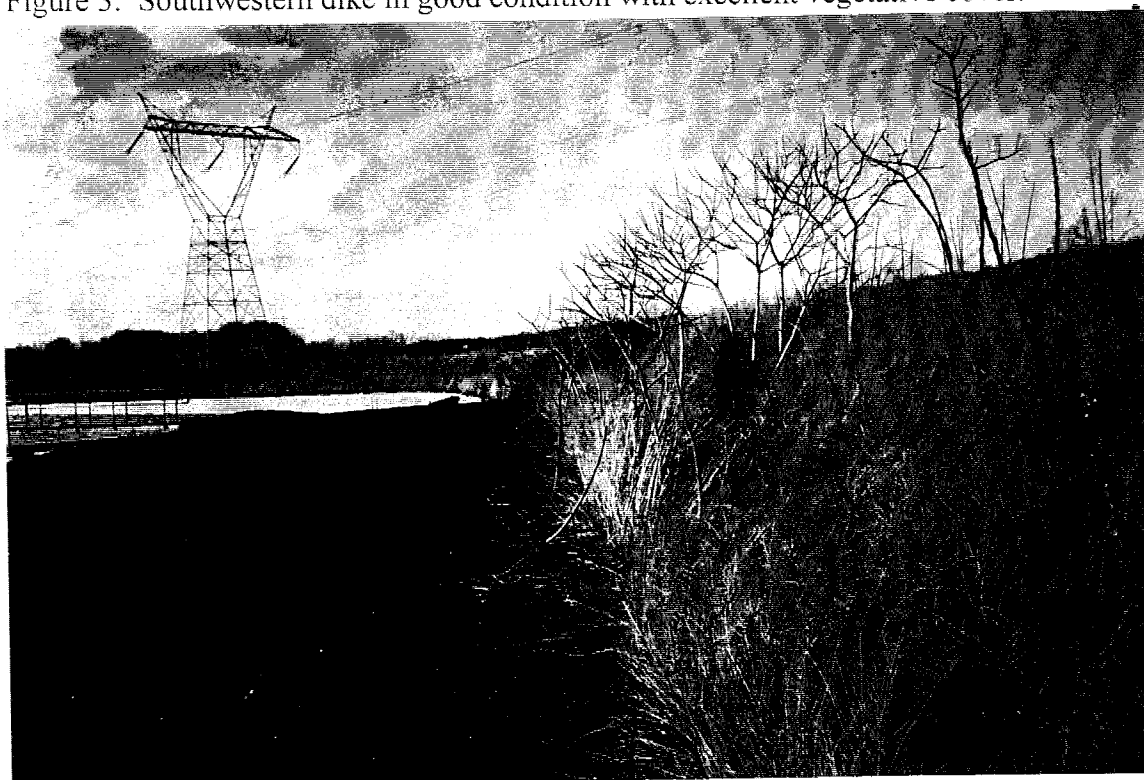
The interior slopes of this area were in good condition with excellent vegetative cover. A small patch of trees were growing on the interior slope of the stilling pool dike above the discharge pipes. The root systems of these trees could eventually cause damage to the pipe joints.

Figure 4. Interior dike of stilling pond. Note growth of small trees above the discharge pipes.

- Monitor the bank erosion along Wells Creek. Please notify Fossil Engineering if the top of bank begins to encroach on the slope of the dike.
- Remove the trees on the interior slope of the stilling pond above the discharge pipes.
