TENNESSEE VALLEY AUTHORITY

SUBJECT: KINGSTON STEAM PLANT - ANNUAL ASH DISPOSAL AREA INSPECTION

On the attached print of drawing 10N420, the different areas are designated.

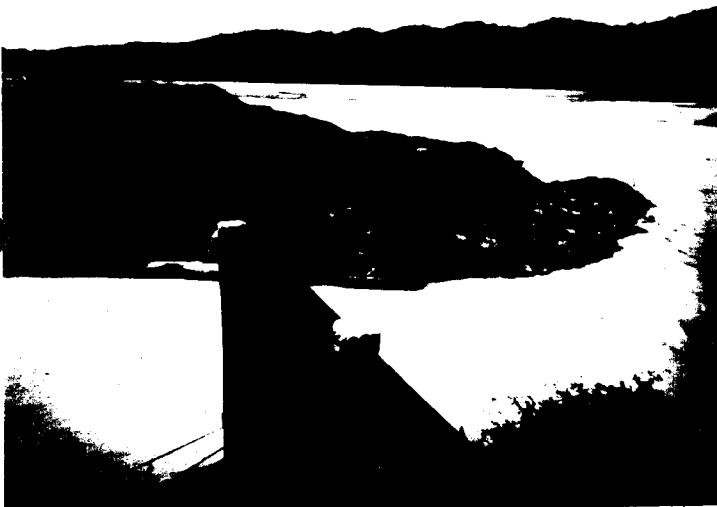
(5)

8. Riprap placement on the divider dike flow-through spillway slopes has deteriorated badly and does not appear to have had any maintenance work (picture 5).
9. A private contractor is presently removing some of the fly ash slurry covering the stilling pool area surface.
10. The weep holes in the concrete end wall of the spillway outlet pipes were seeping; however, not excessively. The dike slope behind the end wall appears dry and well compacted.

Looking into divider dike float-through spillway. Note coarse riprap cover on divider dike slope.
