SUBJECT: KINGSTON STEAM PLANT - ANNUAL POWER ENGINEERING AND CONSTRUCTION AND FOSSIL AND HYDRO POWER JOINT INSPECTION OF THE ASH DISPOSAL AREA

TITLE KINGSTON STEAM PLANT - ALL UNITS - ANNUAL JOINT INSPECTION BY THE DIVISION OF POWER ENGINEERING AND CONSTRUCTION AND THE DIVISION OF FOSSIL AND HYDRO POWER			REPORT NO. FEP-A.SH-88-04	
			PLANT/UNIT KIF-ALL UNITS	
			SAR SECTIONS	
VENDOR	CONTRACT NO.	KEY NOUNS		UNID SYSTEM(S)
	REV	(FOR RIMS USE)	RIMS ACCESSION NUMBER	
APPLICABLE DESIGN DOCUMENTS	R0		B65 '88 0511 001	
	R1			
	R2			
REFERENCES	R3			
	R4

KINGSTON STEAM PLANT

ASH DISPOSAL AREAS

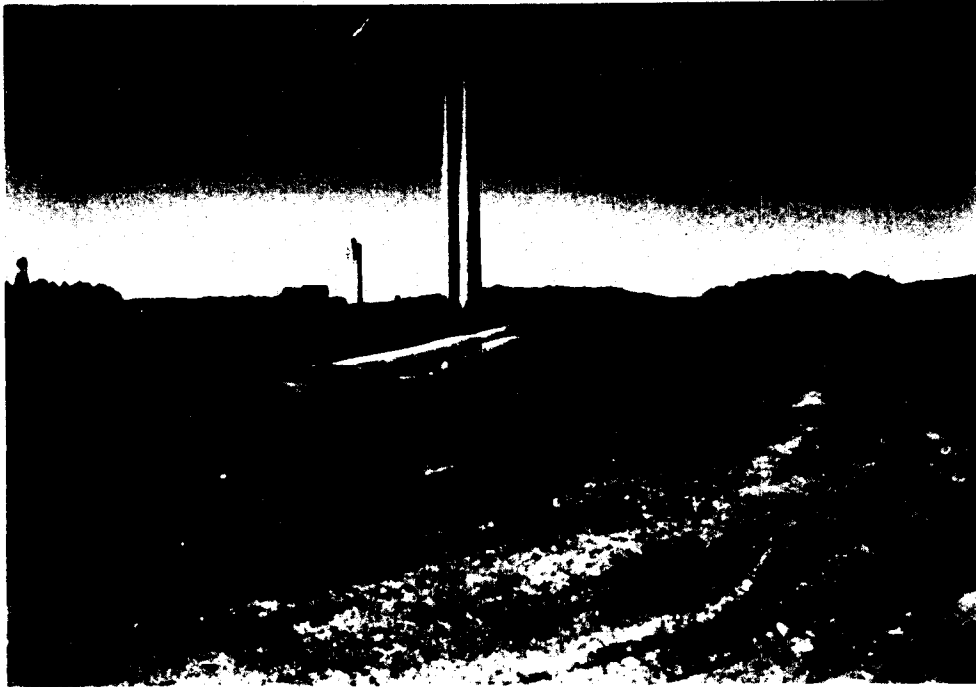
- 2.2 Seepage of redwater still persists along the exterior slope of the southeast dike near its southern end. The majority of the redwater drainage in this area of the disposal area is collected in an interceptor ditch and routed to an engineered wetland for treatment before discharging into the intake channel. At the present time, the discharge to the intake channel has been cut off and is being pumped to the ash pond. The wetland consists of several shallow ponds with cattails and is located as shown on the attached drawing 10W420.

1 REDWATER COLLECTION DITCH.

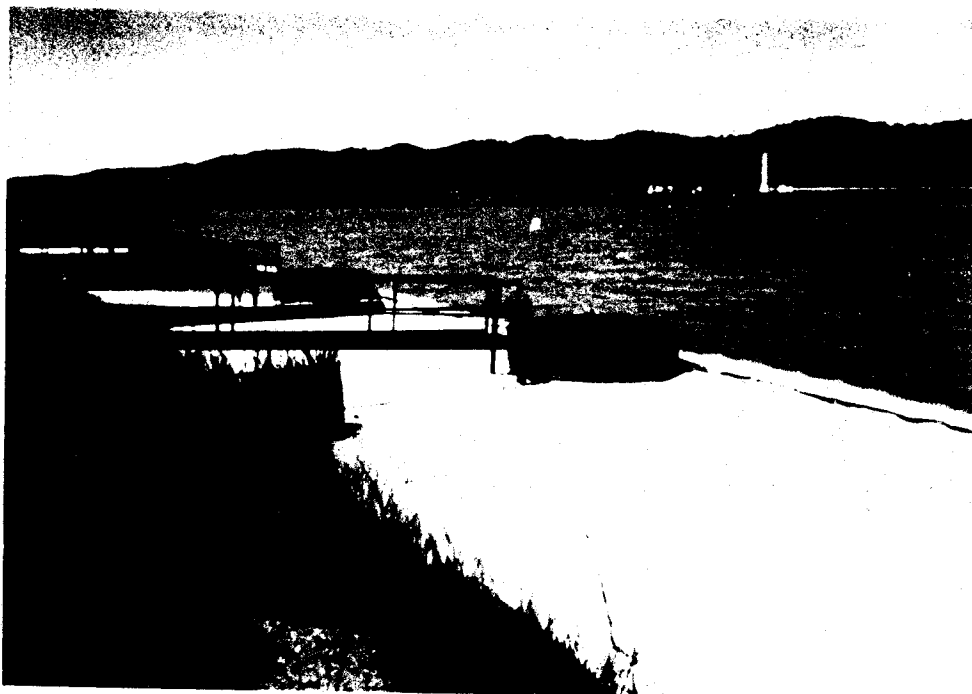
- 4.2 There was a considerable amount of floating ash trapped behind the floating skimmer around the standard spillways and skimmers. Due to this build up of ash, there was a noticeable loss of ash into the spillways (see recommendation No. 6.2).

4 FLOATING ASH AND SPILLWAY SKIMMERS.

- 6.1 All small trees and brush should be removed from the dike's slopes as needed. It is recommended that this undesirable vegetation be removed by chain or cable as to remove the root system from the earth.
- 6.2 The floating ash within the stilling pool needs to be removed to prevent loss through the spillways.
- 6.3 All limbs and algae need to be removed from the spillway skimmers.

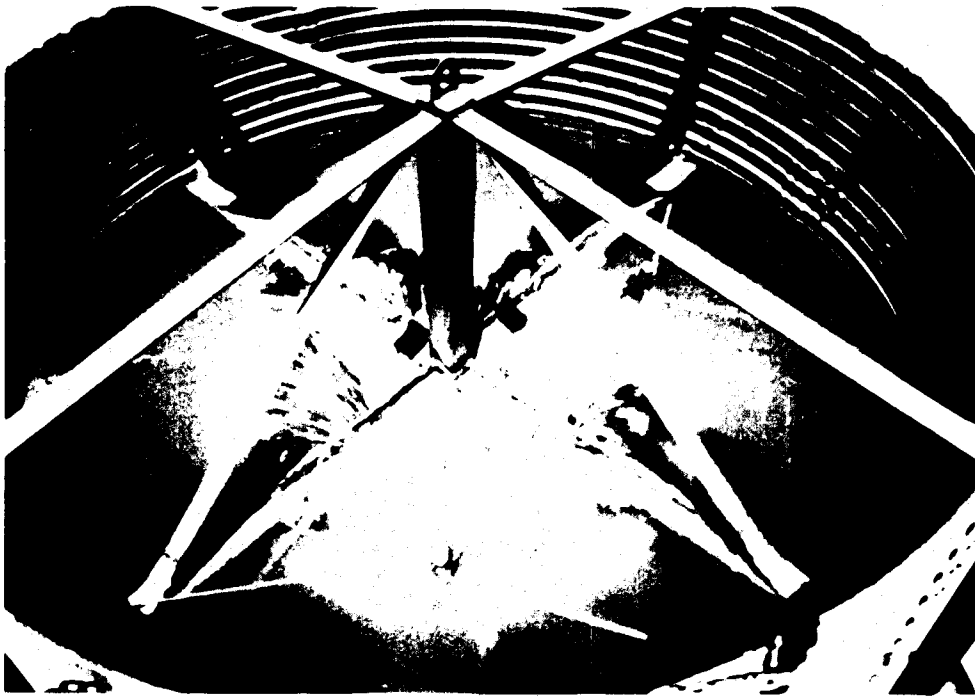
- 4.3 Five of the six standard spillways and skimmers in the stilling pool area appear to be in good condition and functioning properly. The spillway on the west end has been raised one section higher than the other spillways and is not discharging. Several small limbs and a build up of algae was noticed around the spillways and skimmers which could cause inaccurate discharge readings (see recommendation No. 6.3).

5 SPILLWAY

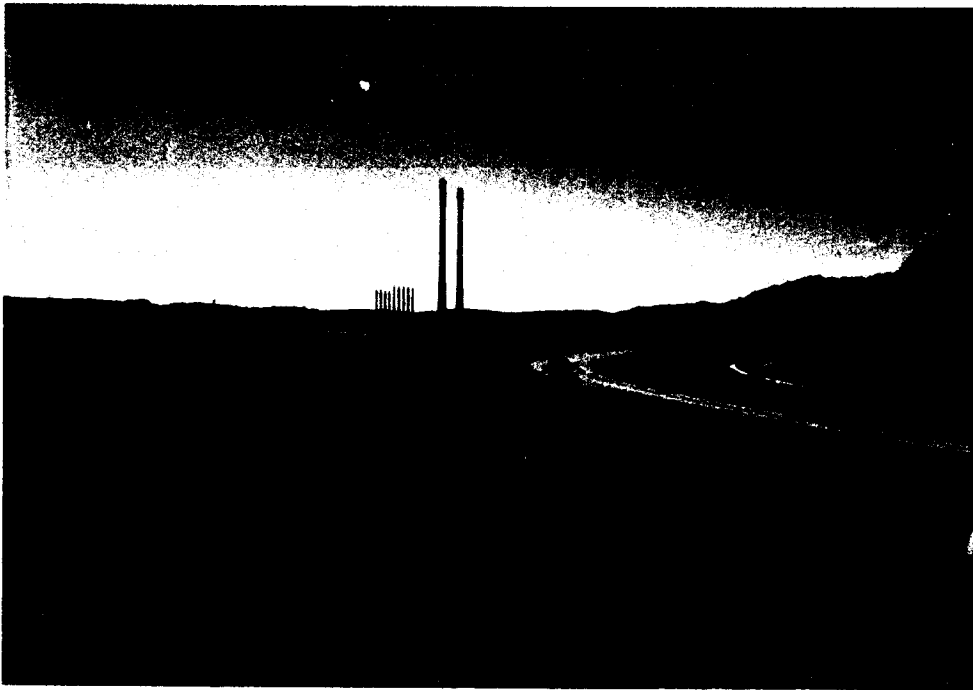
2.1.1 The exterior slopes have a good vegetative cover, and the top of the dikes has a good crushed stone surfacing.

7) GOOD VEGETATION ON EXTERIOR DIKE.

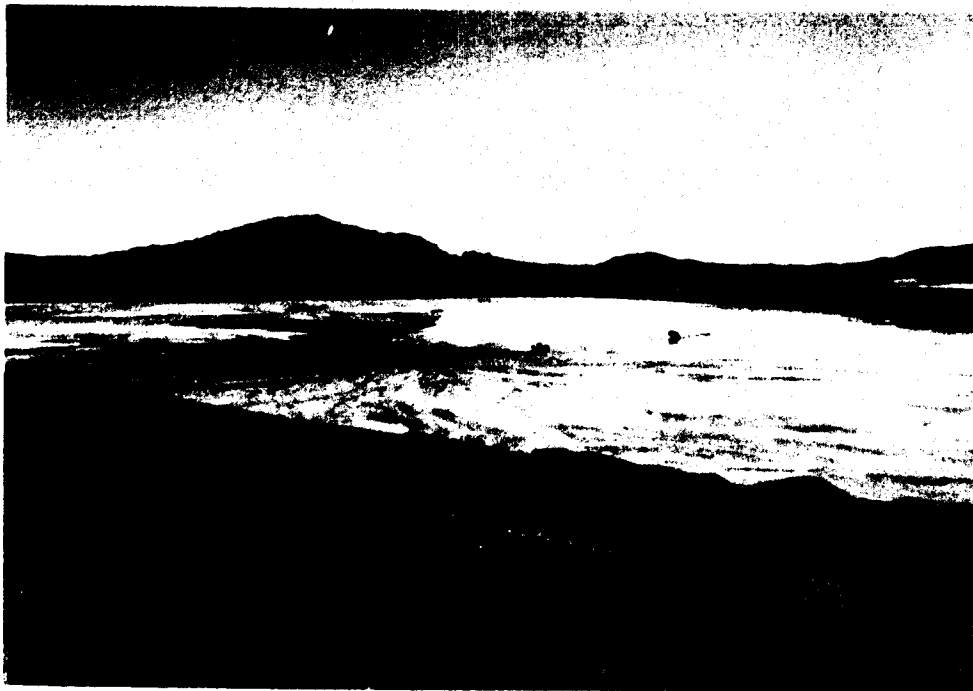
- 3.2 Dredge cell No. 1 has been aerial seeded in an attempt to control dust problems. Success appears to be limited, but the continued growth of grass will determine the overall success. Dredge cell No. 2 has been completed and is presently being dredged into by a contractor. The dikes for dredge cell No. 3 are near completion and this cell will be available later this year for future dredging. All dredge cells were constructed of bottom ash by plant personnel.

8) GREASE CELL NO. 2
