2010 Annual Inspection of CCP Facilities and Ponds

Kingston Fossil Plant
Harriman, Tennessee

Prepared for:
Tennessee Valley Authority
Chattanooga, Tennessee

June 1, 2010

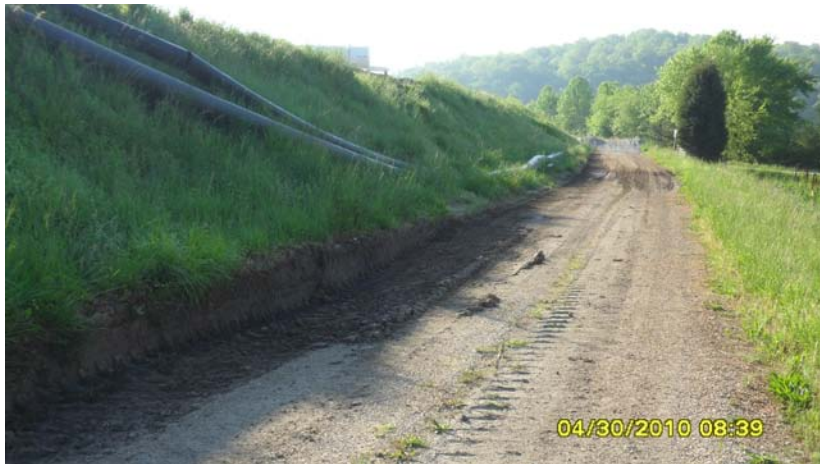
Photo 1

Typical view of lower bench on downstream side of Dike C looking east. Some undercutting at toe of riser dike observed.

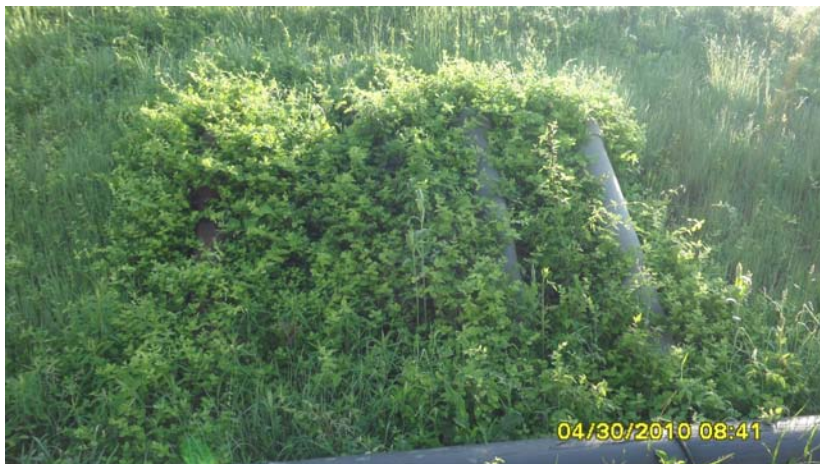
Photo 2

Outlet pipes from Engineered Redwater Wetlands to Ash Pond through Dike C with overgrown vegetation.

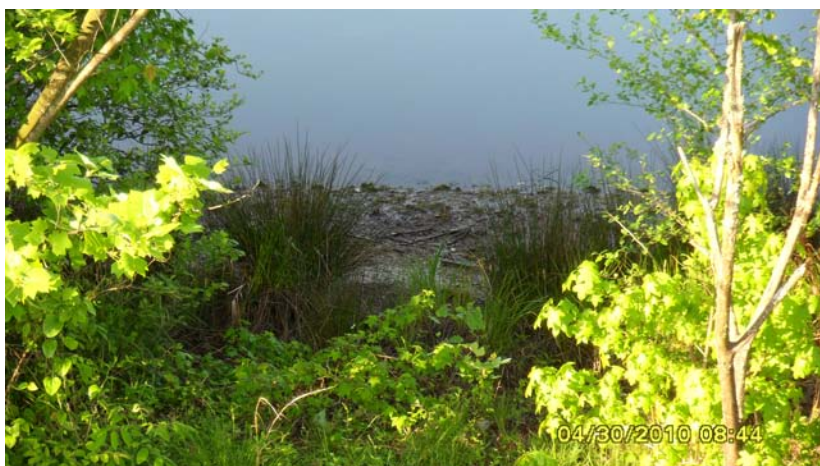
Photo 3

Possible Seepage observed on exterior side of Dike C toward Intake Channel amidst vegetation looking southeast.

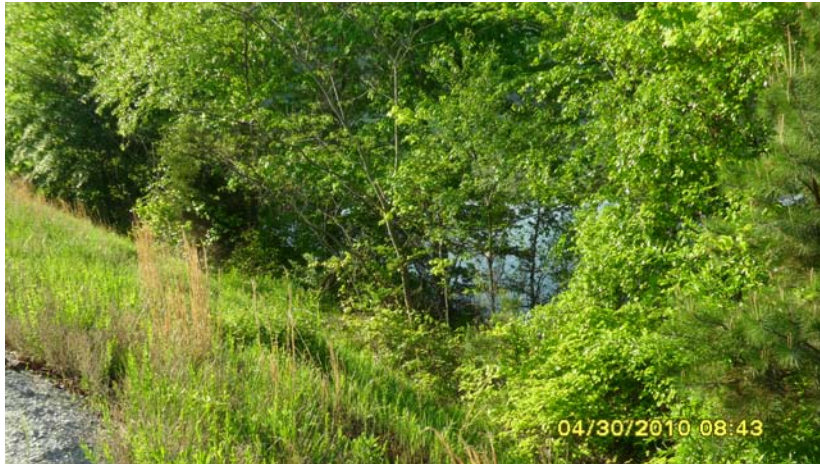
Photo 4

Trees and vegetation on Dike C alongside Intake Channel looking southeast.

- Trees and brush are located on the interior and exterior slopes. It is recommended that trees and brush be removed from these slopes in accordance with the general guidelines shown in Enclosure I. (Priority 4)
- It is recommended that TVA continue to monitor the potential seepage area (Photo 3). The frequency of monitoring should be in accordance with TVA's current inspection program.
- It is recommended that dike rutting (Photo 6) and Dike C toe undercutting (Photo 1) be repaired by placing and compacting material to restore the areas. (Priority 4)

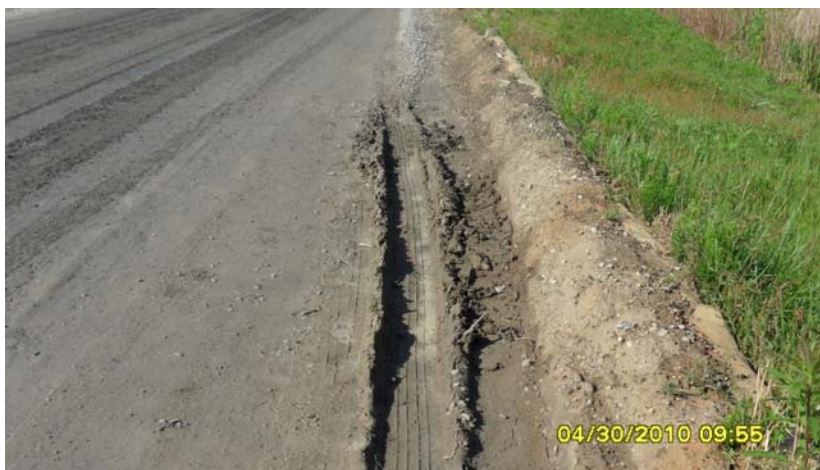
Photo 6

Typical rutting on crest of Dike C looking northeast.

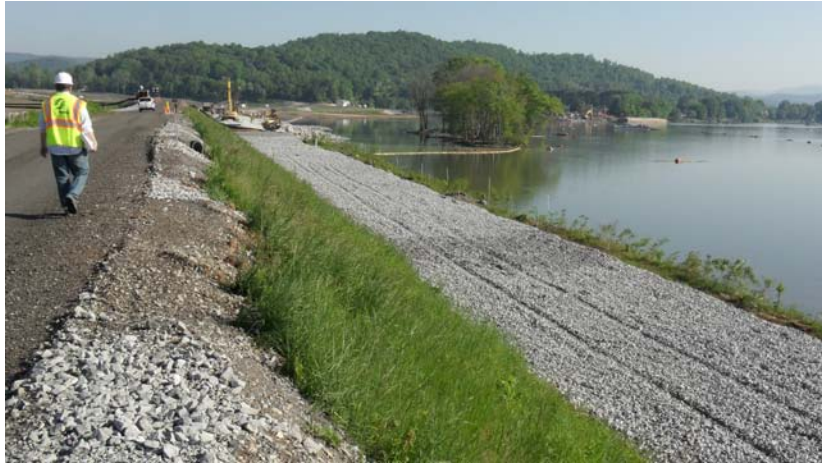
Photo 7

Ongoing buttressing of
Dike C looking northeast.

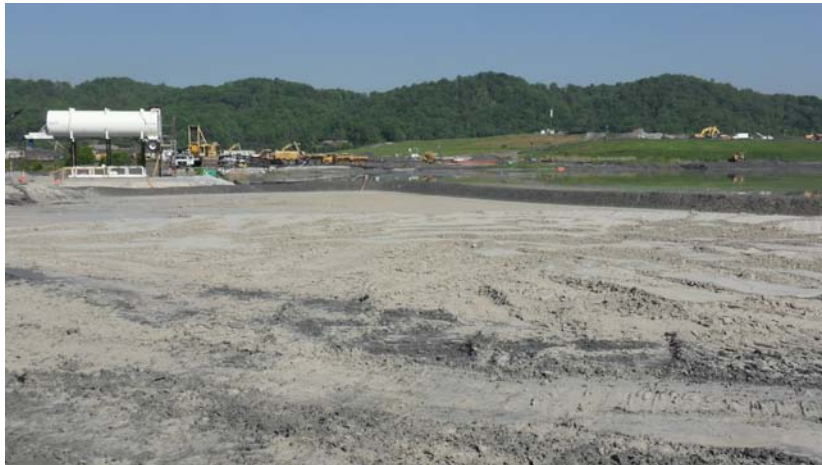
Photo 8

Cenospheres and ash
deposits in south end of
Ash Pond looking west
from Divider Dike.

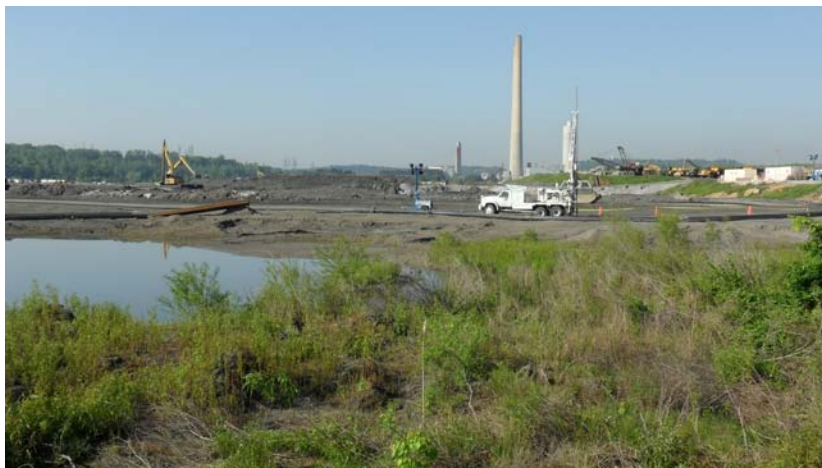
Photo 9

View looking south of
settled ash with sparse
vegetation in foreground
near intersection with Dike
D. Ongoing work for
Lateral Expansion in
background.

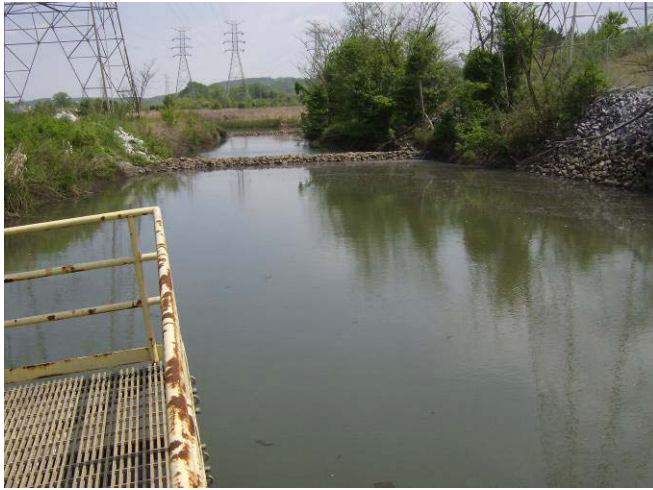
Photo 10

View of rock check dams from floating pump structure looking east. Trees and storm water outlet visible on south slope in upper right of photo.

- It is recommended that the 2 rock check dams located in the drainage basin be cleaned and repaired as needed.
- It is recommended that TVA personnel monitor the storage capacity and pool level of the basin and perform dredging and pumping as needed to maintain sufficient capacity. (Priority 5)

- Trees and brush are located on the interior and exterior slopes. It is recommended that trees and brush be removed from these slopes in accordance with the general guidelines shown in Enclosure I. (Priority 4)

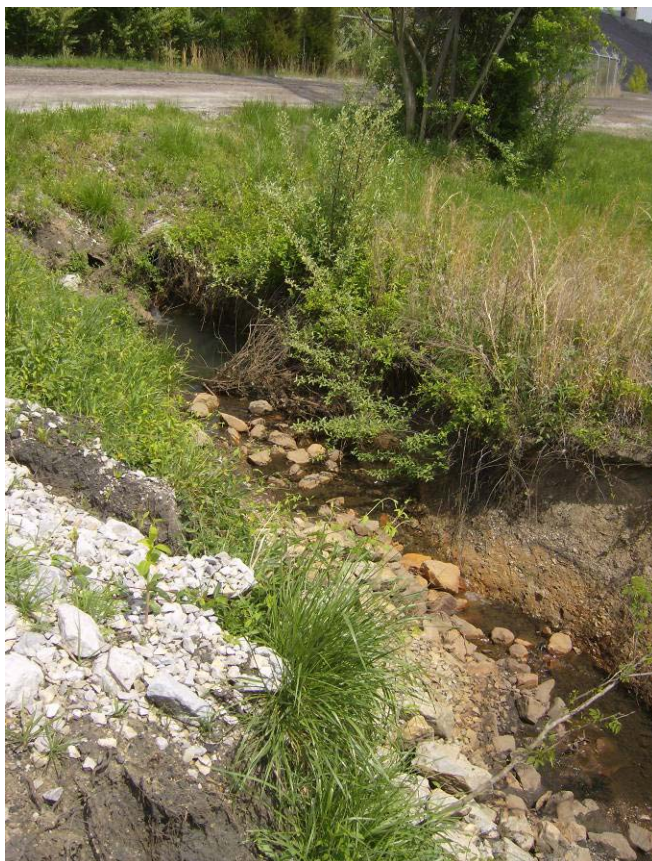
Photo 14

slopes (Photos 10 and 11).
Wave Wash Protection:	N/A
Erosion:	Severe localized erosion at inlet pipe on north embankment of pond. Soil eroded and undercut area approximately 10 feet by 3 feet (Photo 14).
Instabilities:	Slough several feet across observed immediately west of inlet erosion on pond embankment (Photo 15).
Animal Burrows:	None observed.
Freeboard:	Approximately 6 feet (estimated).
Encroachments:	None observed.
Slope:	Estimated at approximately 2H:1V.
4.2. Crest	
Crest Cover and Slope:	N/A
Erosion:	N/A
Alignment:	N/A
Settlement/Cracking:	N/A
Bare Spots/Rutting:	N/A
Width:	N/A
4.3. Exterior Slopes	
Vegetation:	N/A
Trees:	N/A
Erosion:	N/A
Instabilities:	N/A
Uniform Appearance:	N/A
Seepage:	N/A
Benches:	N/A
Foundation Drains, and	N/A

Erosion undercutting inlet pipe northward from drainage pond.

- It is recommended that the large undermined area with adjacent slough be repaired (Photos 14 and 15). These and other eroded areas should be cleaned of loose/sloughed material, re-filled, and re-seeded. Filling procedures should include cutting foundation benches (as necessary), placing clay in maximum 6-inch lifts, and compacting with small compaction equipment such as a jumping jack or a hand-held mechanical tamper. An erosion control blanket should be placed after seeding. (Priority 4)

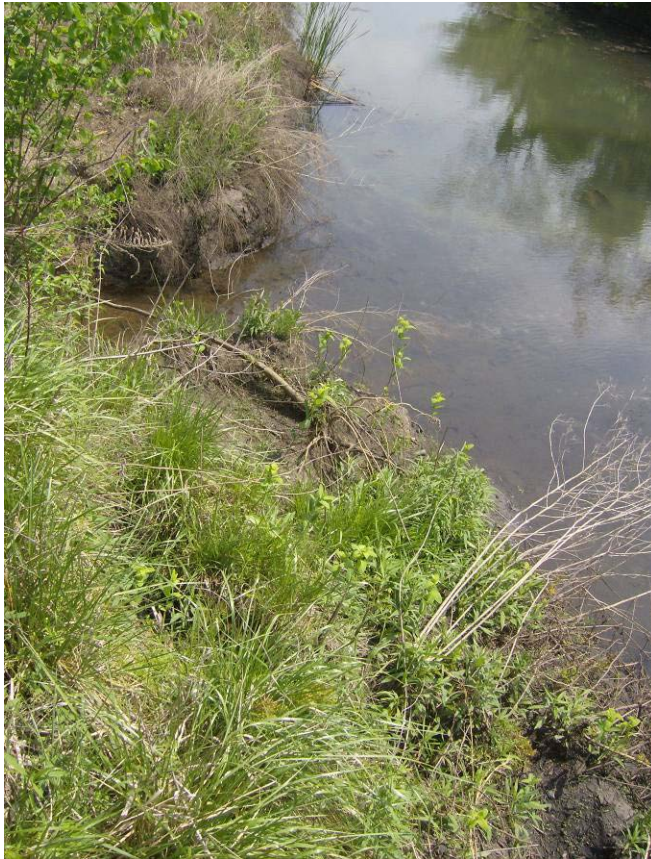
Photo 15

Sloughing on the north slope near eroded inlet as shown in Photo 5.

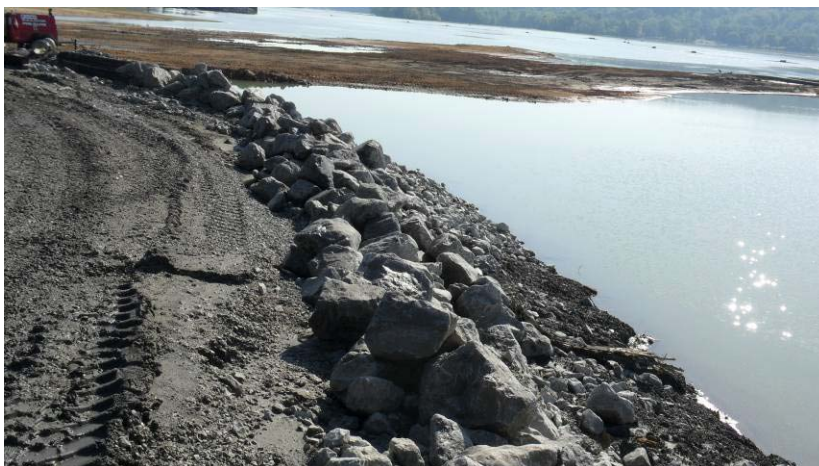
Photo 18

Shot rock on downstream (river side) slope. Emory River in background.

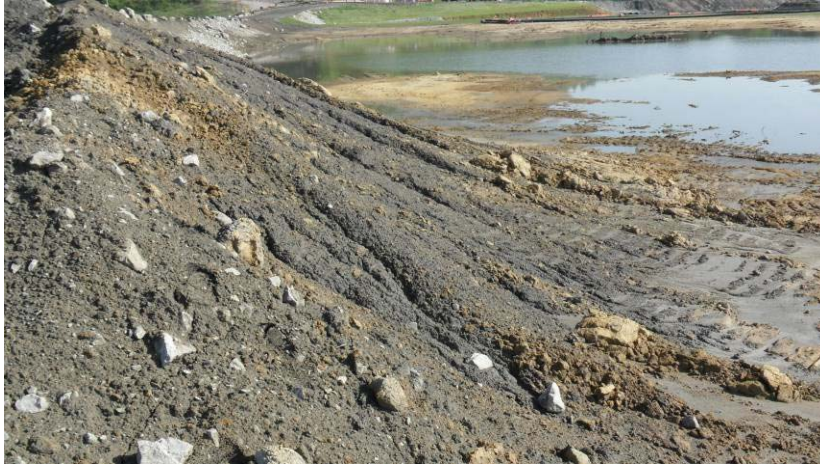
Photo 19

Minor surficial erosion located on river side of Dike 2 in exposed ash.

- It is recommended that TVA continue to periodically clean out holding ponds by mechanical dredging. Perform as needed.
- It is recommended that TVA monitor crests and slopes of the temporary basin and regrade rutting and erosion as may be needed. Stantec observed some minor rutting/erosion (Photo 19) beginning to form. (Priority 3)

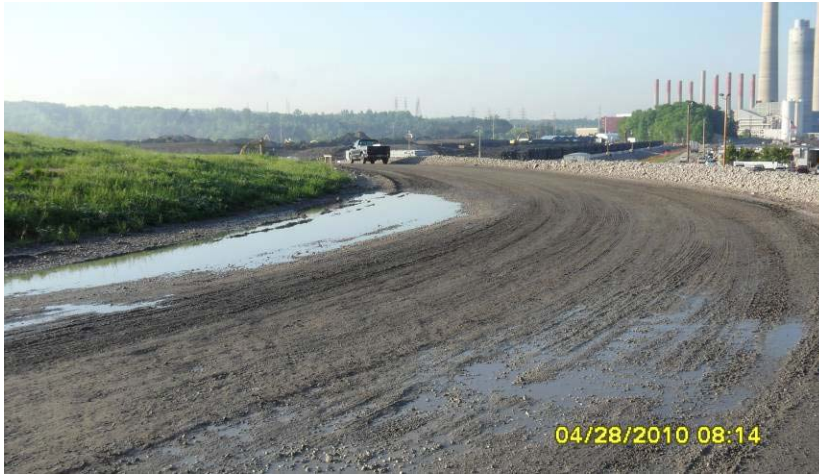
Photo 22

Shot rock haul road constructed on southwest corner of Dike C. Ponding water observed.

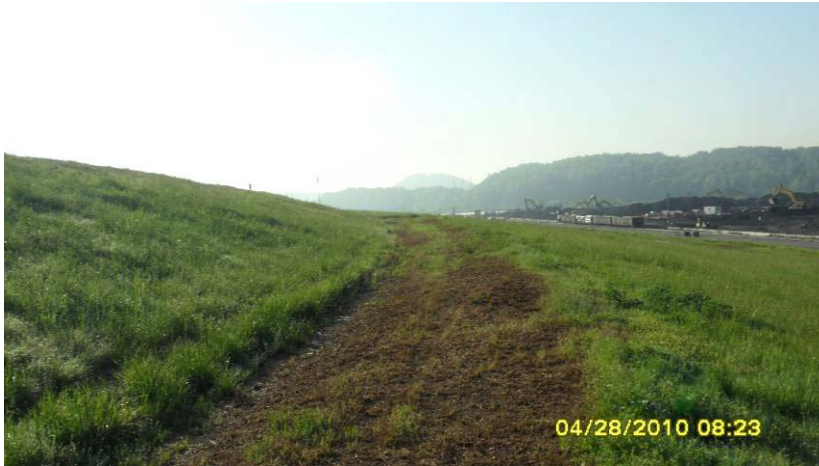
Photo 25

Typical Dike C bench, looking east.

- A few areas lacking adequate vegetation coverage were noted in this inspection along Dikes C and D (Photos 25, 27, 29, and 32). Re-seeding of these areas should be performed to re-establish vegetation growth. Erosion control blankets should be used since the areas are on sloping ground. (Priority 4)

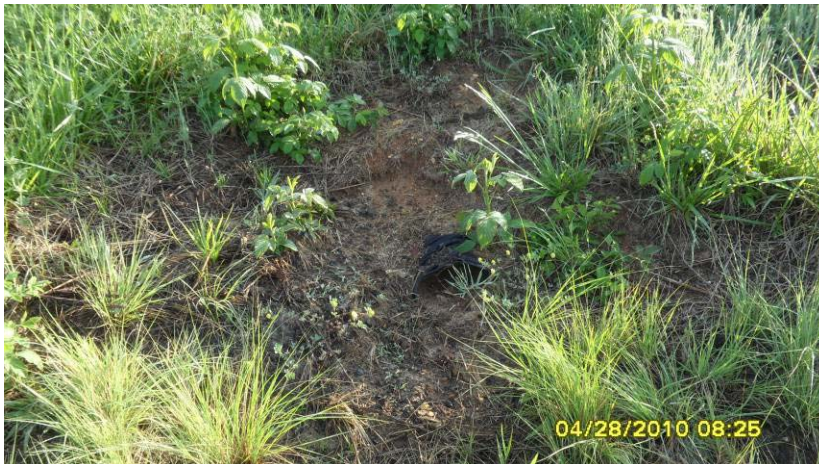
Photo 26

to minor washouts (Photo 27). Some minor erosion of ash from the test trench was also observed extending east and west on the middle bench (Photos 34 and 35). A clogged drain pipe will was observed (Photo 26). A localized erosion feature in an exposed area of ash was observed on the southwest corner (Photo 28).

Clogged drainage pipe on south side of Dredge Cell Dike C.

- It is recommended that the clogged drainage pipe (Photo 26) outlet be cleared and the pipe be evaluated to determine its current working condition and promote positive drainage. (Priority 4)

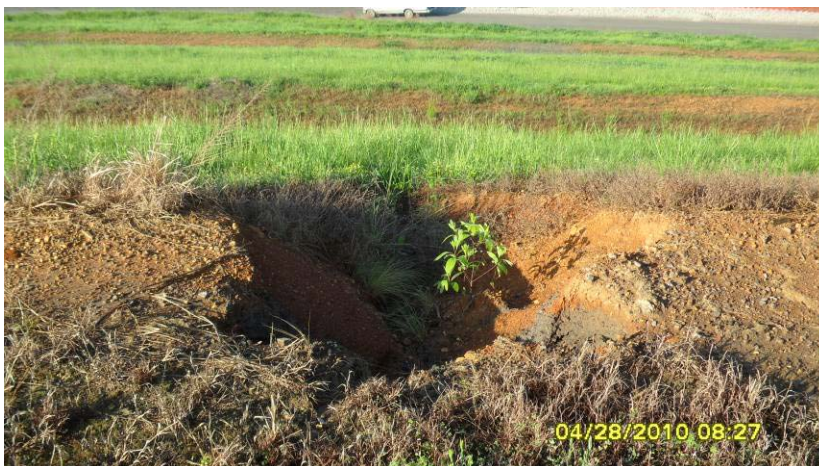
Photo 27

Erosion washout on south face of Dredge Cell, second bench, with areas of sparse vegetation on lower benches visible in background.

- Numerous areas of erosion and/or rutting with standing water were observed during the inspection include areas along both Dike C and Die D (Photos 27, 29, 30, 37, and 38). It is recommended that these areas be drained and/or subsequently filled/graded and in accordance with current site protocols for erosion repair and temporary vegetative cover. Filling should consist of placing select ash or clay and compacting with small compaction equipment, such as a jumping jack, or hand-held tampers. Some excavation may be required to create foundation benches to allow compaction to occur on level ground. Erosion control blankets should be used for the areas on sloping ground. (Priority 4)

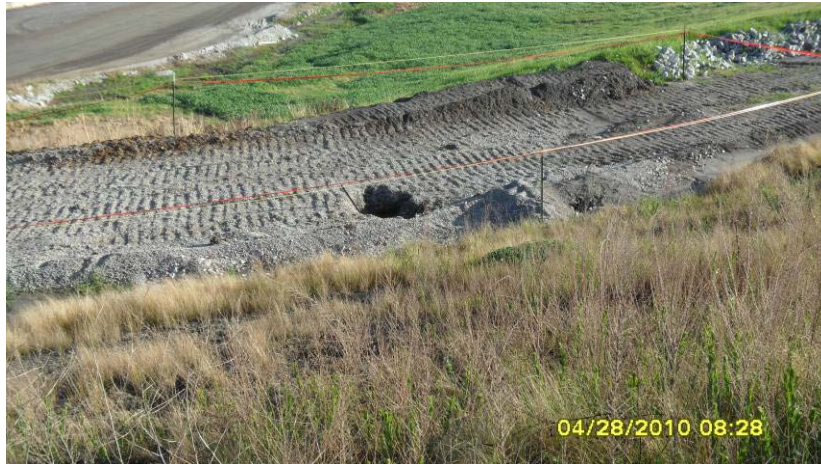
Photo 28

Ash erosion feature encountered at southwest corner of Dike C.

- It is recommended that the erosion feature encountered in exposed ash (Photo 28) be excavated and re-filled with suitable ash materials in accordance with general site erosion control protocols. (Priority 4)

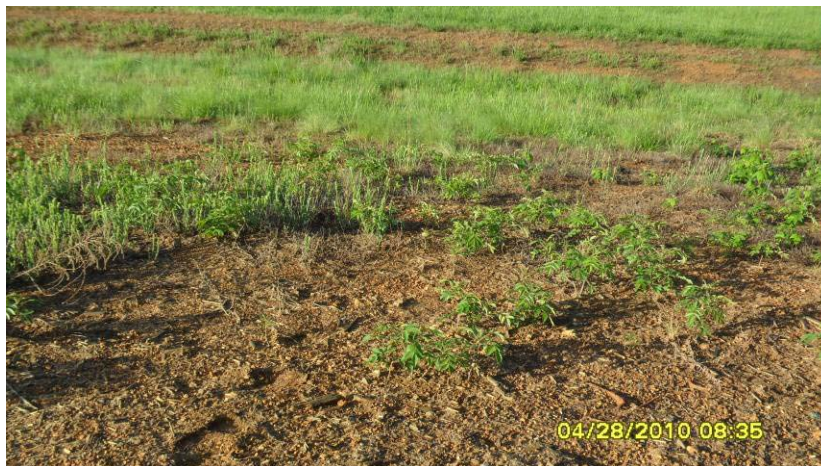
Photo 29

Minor erosion with sparse vegetation on south side of Dredge Cell.

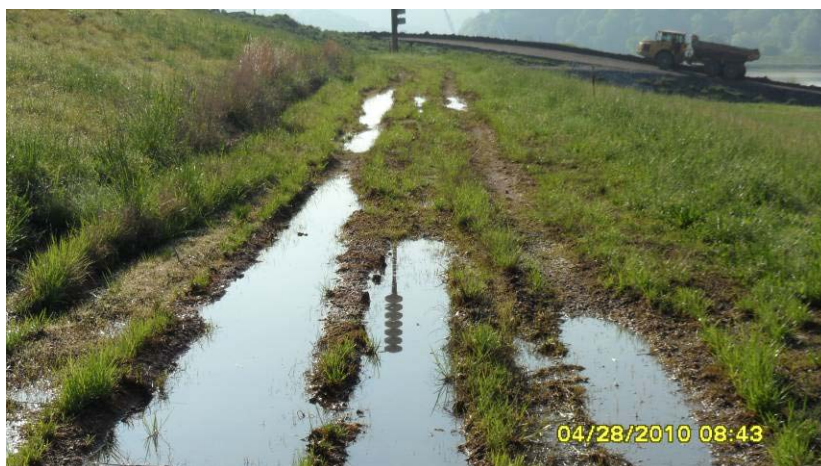
Photo 30

Typical ponding and rutting for Dike C on south side of Dredge Cell, looking east.

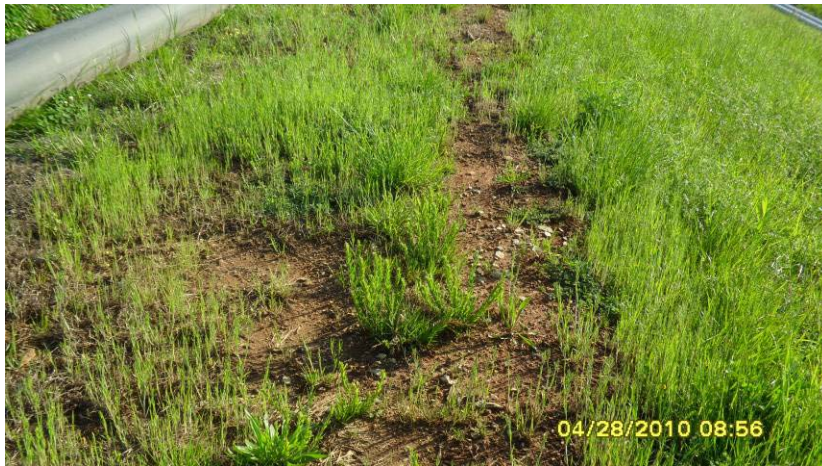
Photo 32

Minor erosion with additional vegetative cover required along Dike D.

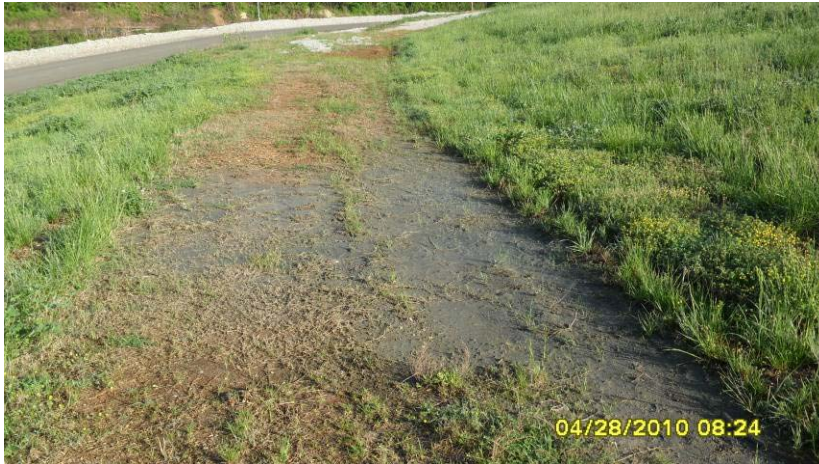
Photo 34

View looking west on second bench of ash deposits on Dike C from erosion of test trench (see Photo 15).

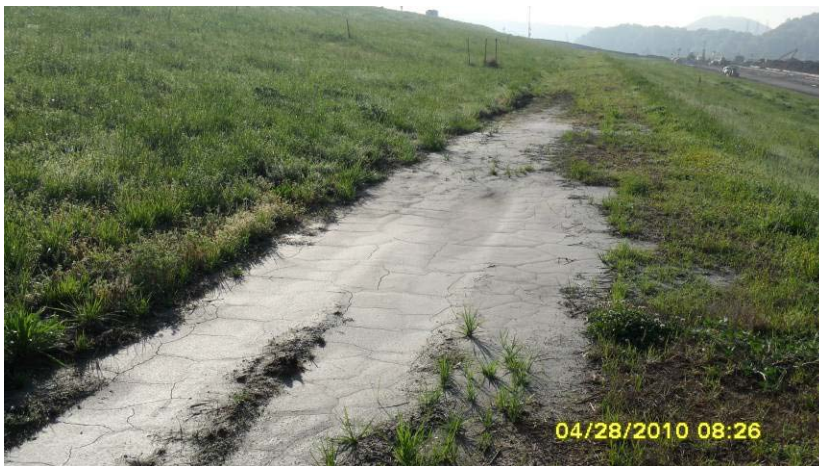
Photo 35

View looking east on second bench of ash deposits on Dike C from erosion of test trench (see Photo 36).

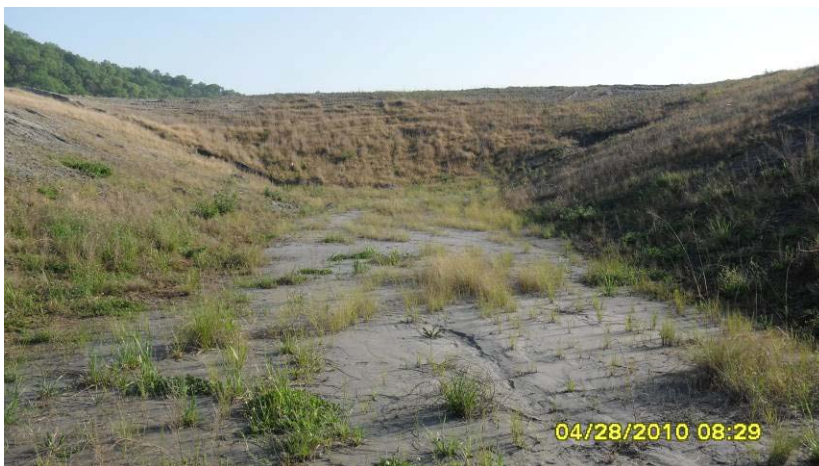
Photo 36

Ash erosion at top of Dike C in the test trench.

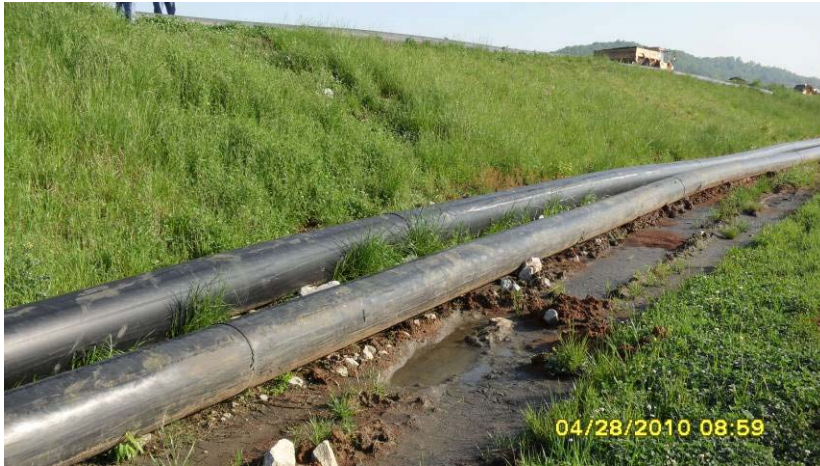
Photo 37

Dredge lines, rutting, and ponding on middle bench of Dike D, looking northwest.

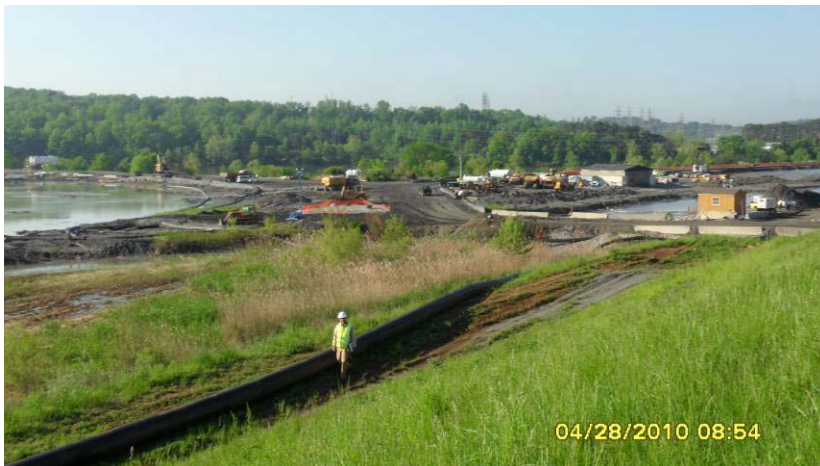
Photo 38

Trees: Few small trees observed at base of Dike D to the east of the southeast corner of the Dredge Cell just north of the Rim Ditch and Sluice Trench (Photo 38).

Southeast corner of Dredge Cell just north of Sluice Trench/Rim Ditch.

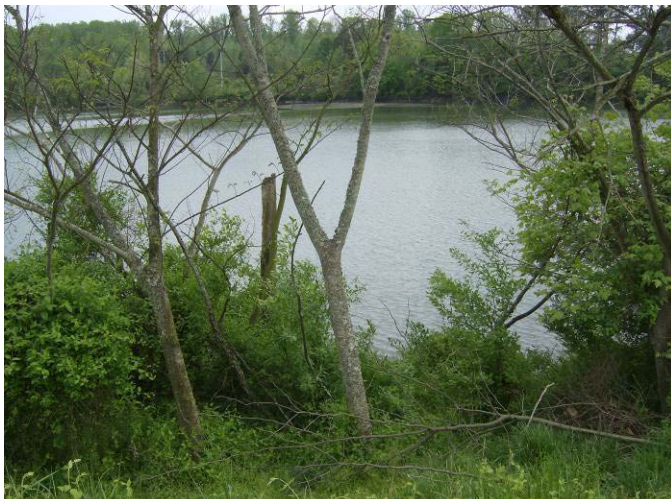
Photo 41

Thick vegetation and trees between access road and Intake Channel.

- Trees and brush are located on the interior and exterior slopes. It is recommended that trees and brush be removed from these slopes in accordance with the general guidelines shown in Enclosure I. (Priority 4)
- It is recommended that floating debris/vegetation observed within the discharge pump structures be removed so the pumps do not become clogged or damaged. (Priority 3)
- It is recommended that the seepage observed along the Intake Channel waterline continue to be monitored in the interim until mitigation designs are implemented in association with Ash Pond closure and plant conversion from wet to dry ash handling.

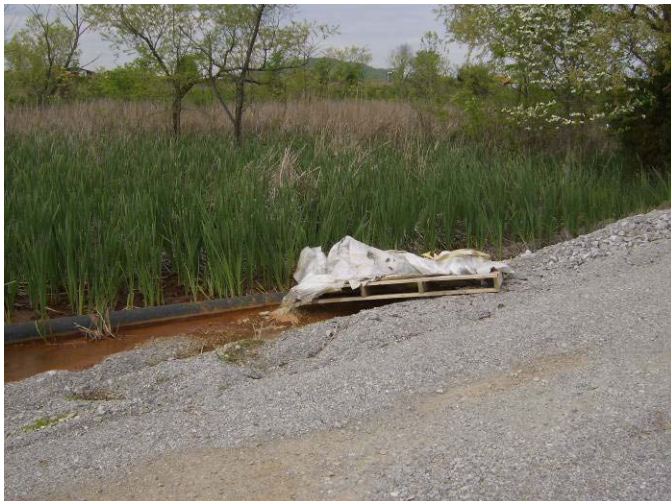
Photo 43

Construction debris located on west side of access road with thick vegetation in the Redwater Wetlands.

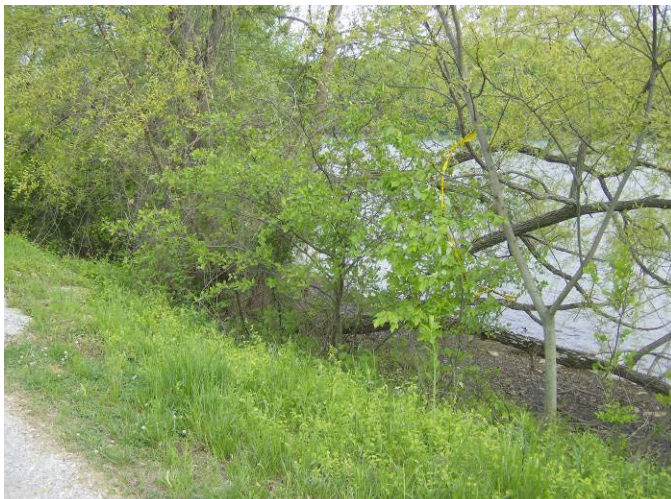
Photo 44

Thick vegetation and trees on the slopes of the Intake Channel with sparse cover near waterline, looking north/northeast from the access road.

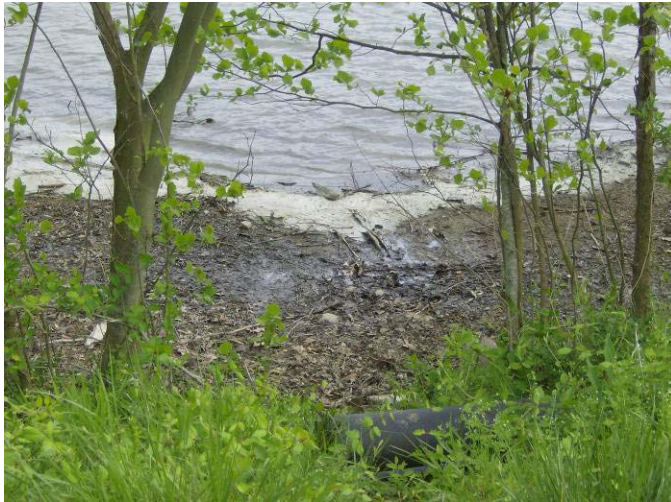
Photo 45

Typical seepage observed along Intake Channel.

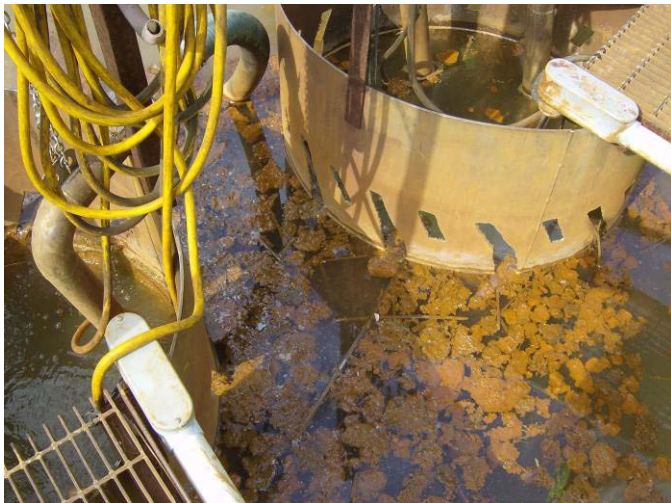
Photo 46

Various debris floating near and within the two active morning glory spillways for the discharge pumps in collection pond.

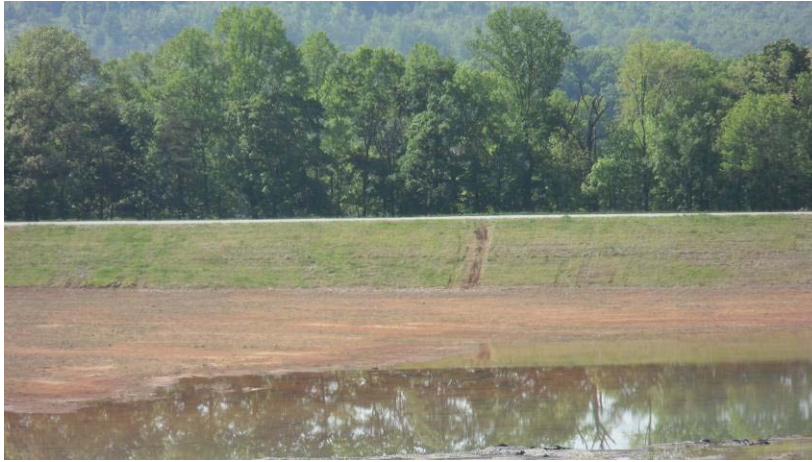
Photo 47

View of erosion feature on south slope looking to the south from north side. Vegetation not present in some areas.

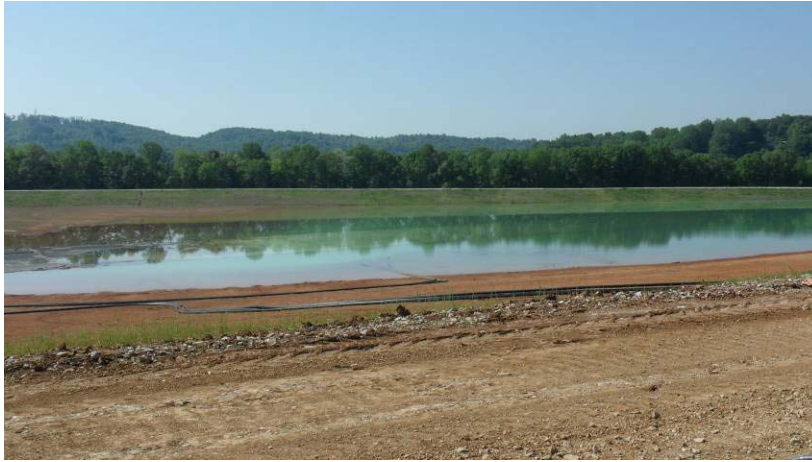
Photo 50

Typical view of lack of vegetative cover. Several feet of water present in much of pond at time of inspection.

- Many areas lacking adequate vegetation coverage were noted in this inspection along the perimeter of the Gypsum Pond (Photo 50). Re-seeding of these areas should be performed to re-establish vegetation growth. Erosion control blankets should be used since the areas are on sloping ground. (Priority 4)

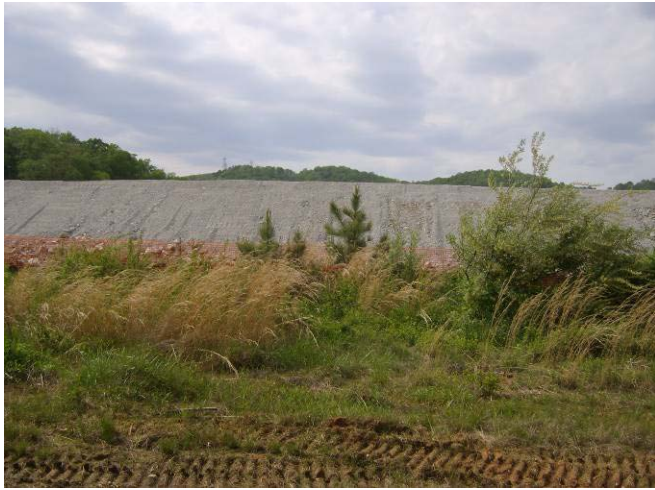
Photo 51

Road constructed in corridor between Sluice Trench to the west and Intake Channel to the east. Typical minor surface rutting on east dike visible in foreground.

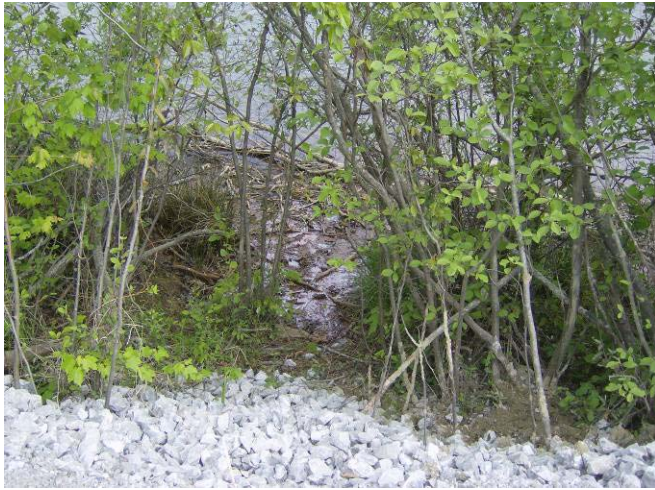
Photo 54

Typical view of redwater seepage observed, looking east into Intake Trench. Note: crushed stone in foreground placed as working platform for drilling operations that had recently been conducted to monitor seepage.

- It is recommended that the seepage observed along the Intake Channel waterline continue to be monitored. Stantec understands that Geosyntec has been tasked with this effort initiate a mitigation plan.

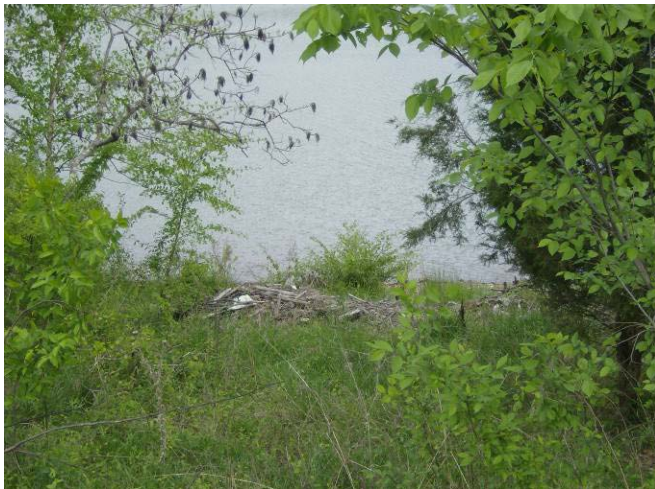
Photo 55

Debris located on the exterior slope, looking east.

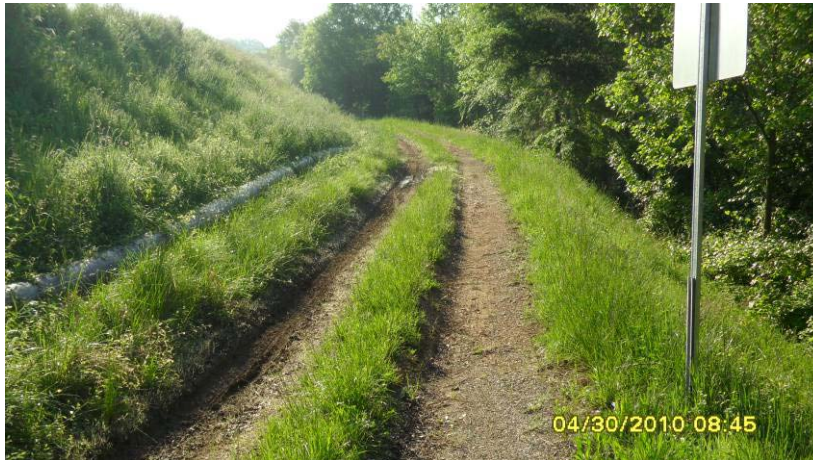
Photo 56

Typical view of access roadway on lower bench of Dike C with some minor rutting and exposed soil.

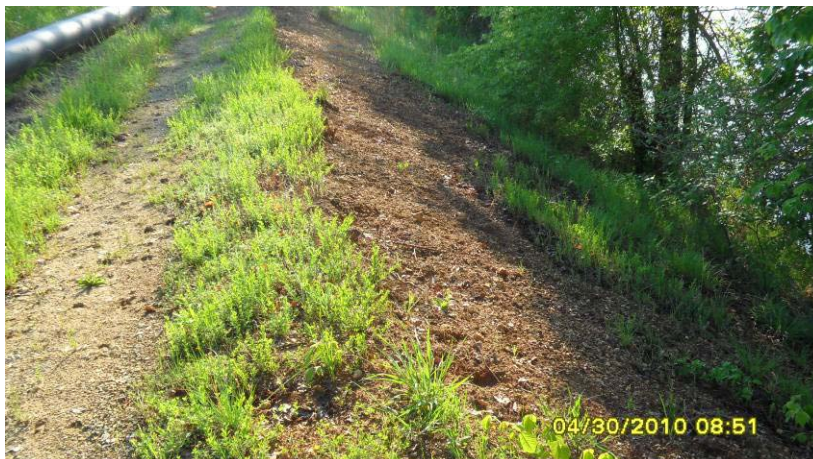
Photo 57

Sparse vegetation on exterior slopes of Dike C.

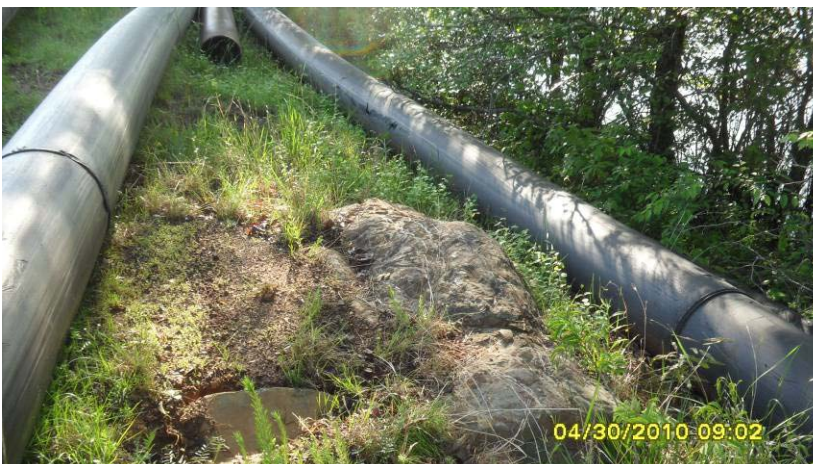
Photo 58

Boulder observed alongside dredge pipes on exterior slopes of Dike C adjacent to Intake Channel.

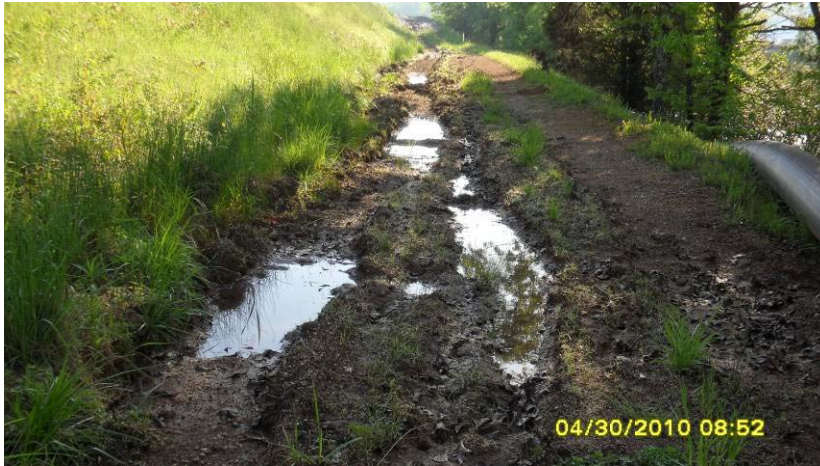
Photo 59

Typical view of more significant rutting and standing water on bench of exterior slope; looking east adjacent to the Intake Channel with numerous trees present at toe of Dike C.

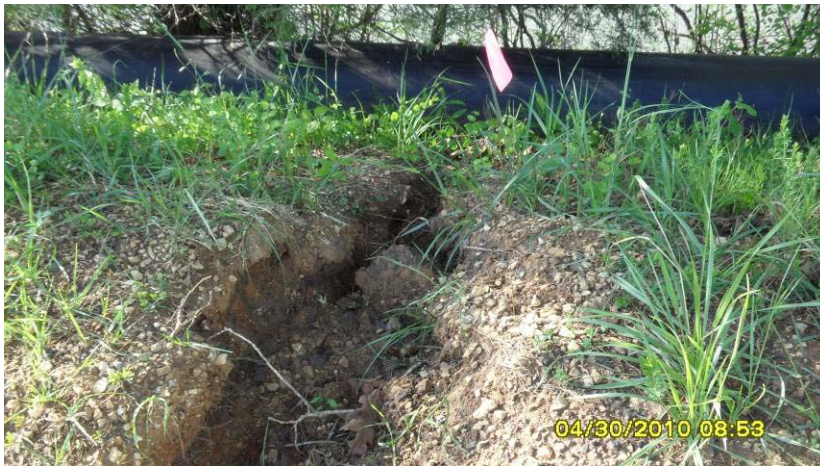
Photo 60

Typical erosion washout on exterior bench of Dike C.

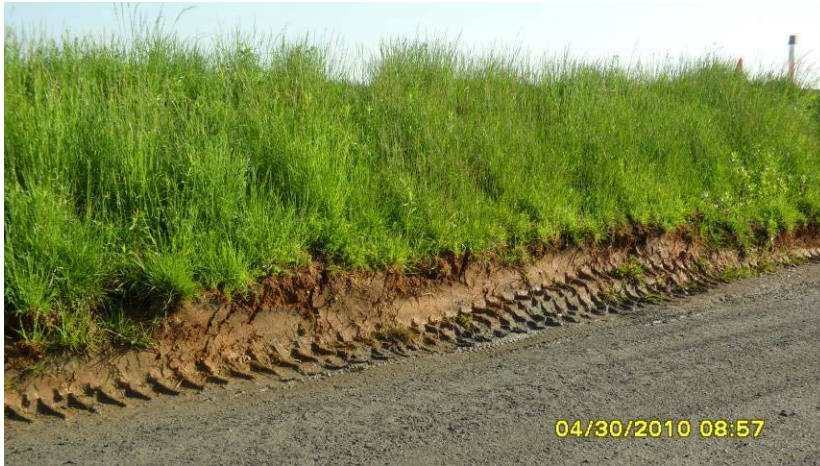
Photo 62

Steep cut approximately 5 feet high on crest of Dike C with exposed clay and minor rutting.

- Re-grading should be considered at the areas along the crest of Dike C near the catwalk to the spillways exhibiting very steep slopes (Photo 62) to reduce future potential for localized sloughing. (Priority 5)

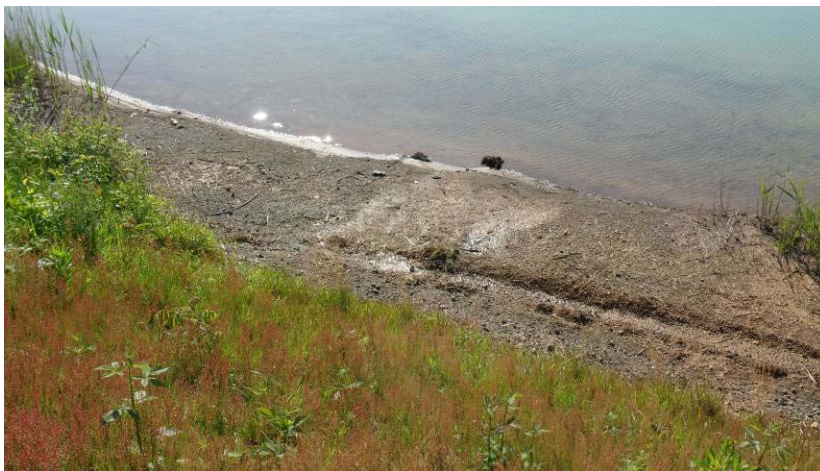
Photo 66

Possible seepage into Stilling Pond through Divider Dike, looking east.

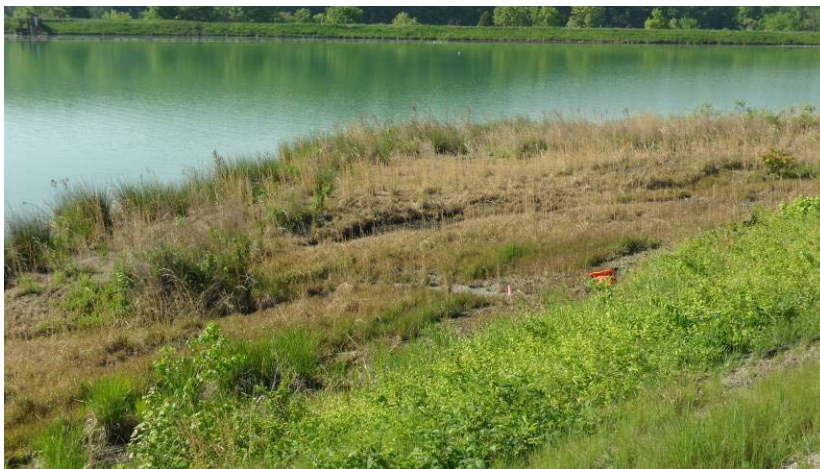
Photo 67

Ash deposit with sparse vegetation along Divider Dike in Stilling Pond. Dike C in background.
