TENNESSEE VALLEY AUTHORITY

SUBJECT: KINGSTON STEAM PLANT - ANNUAL ASH DISPOSAL AREA INSPECTION

On the attached print of drawing 10N420, the different areas are designated.

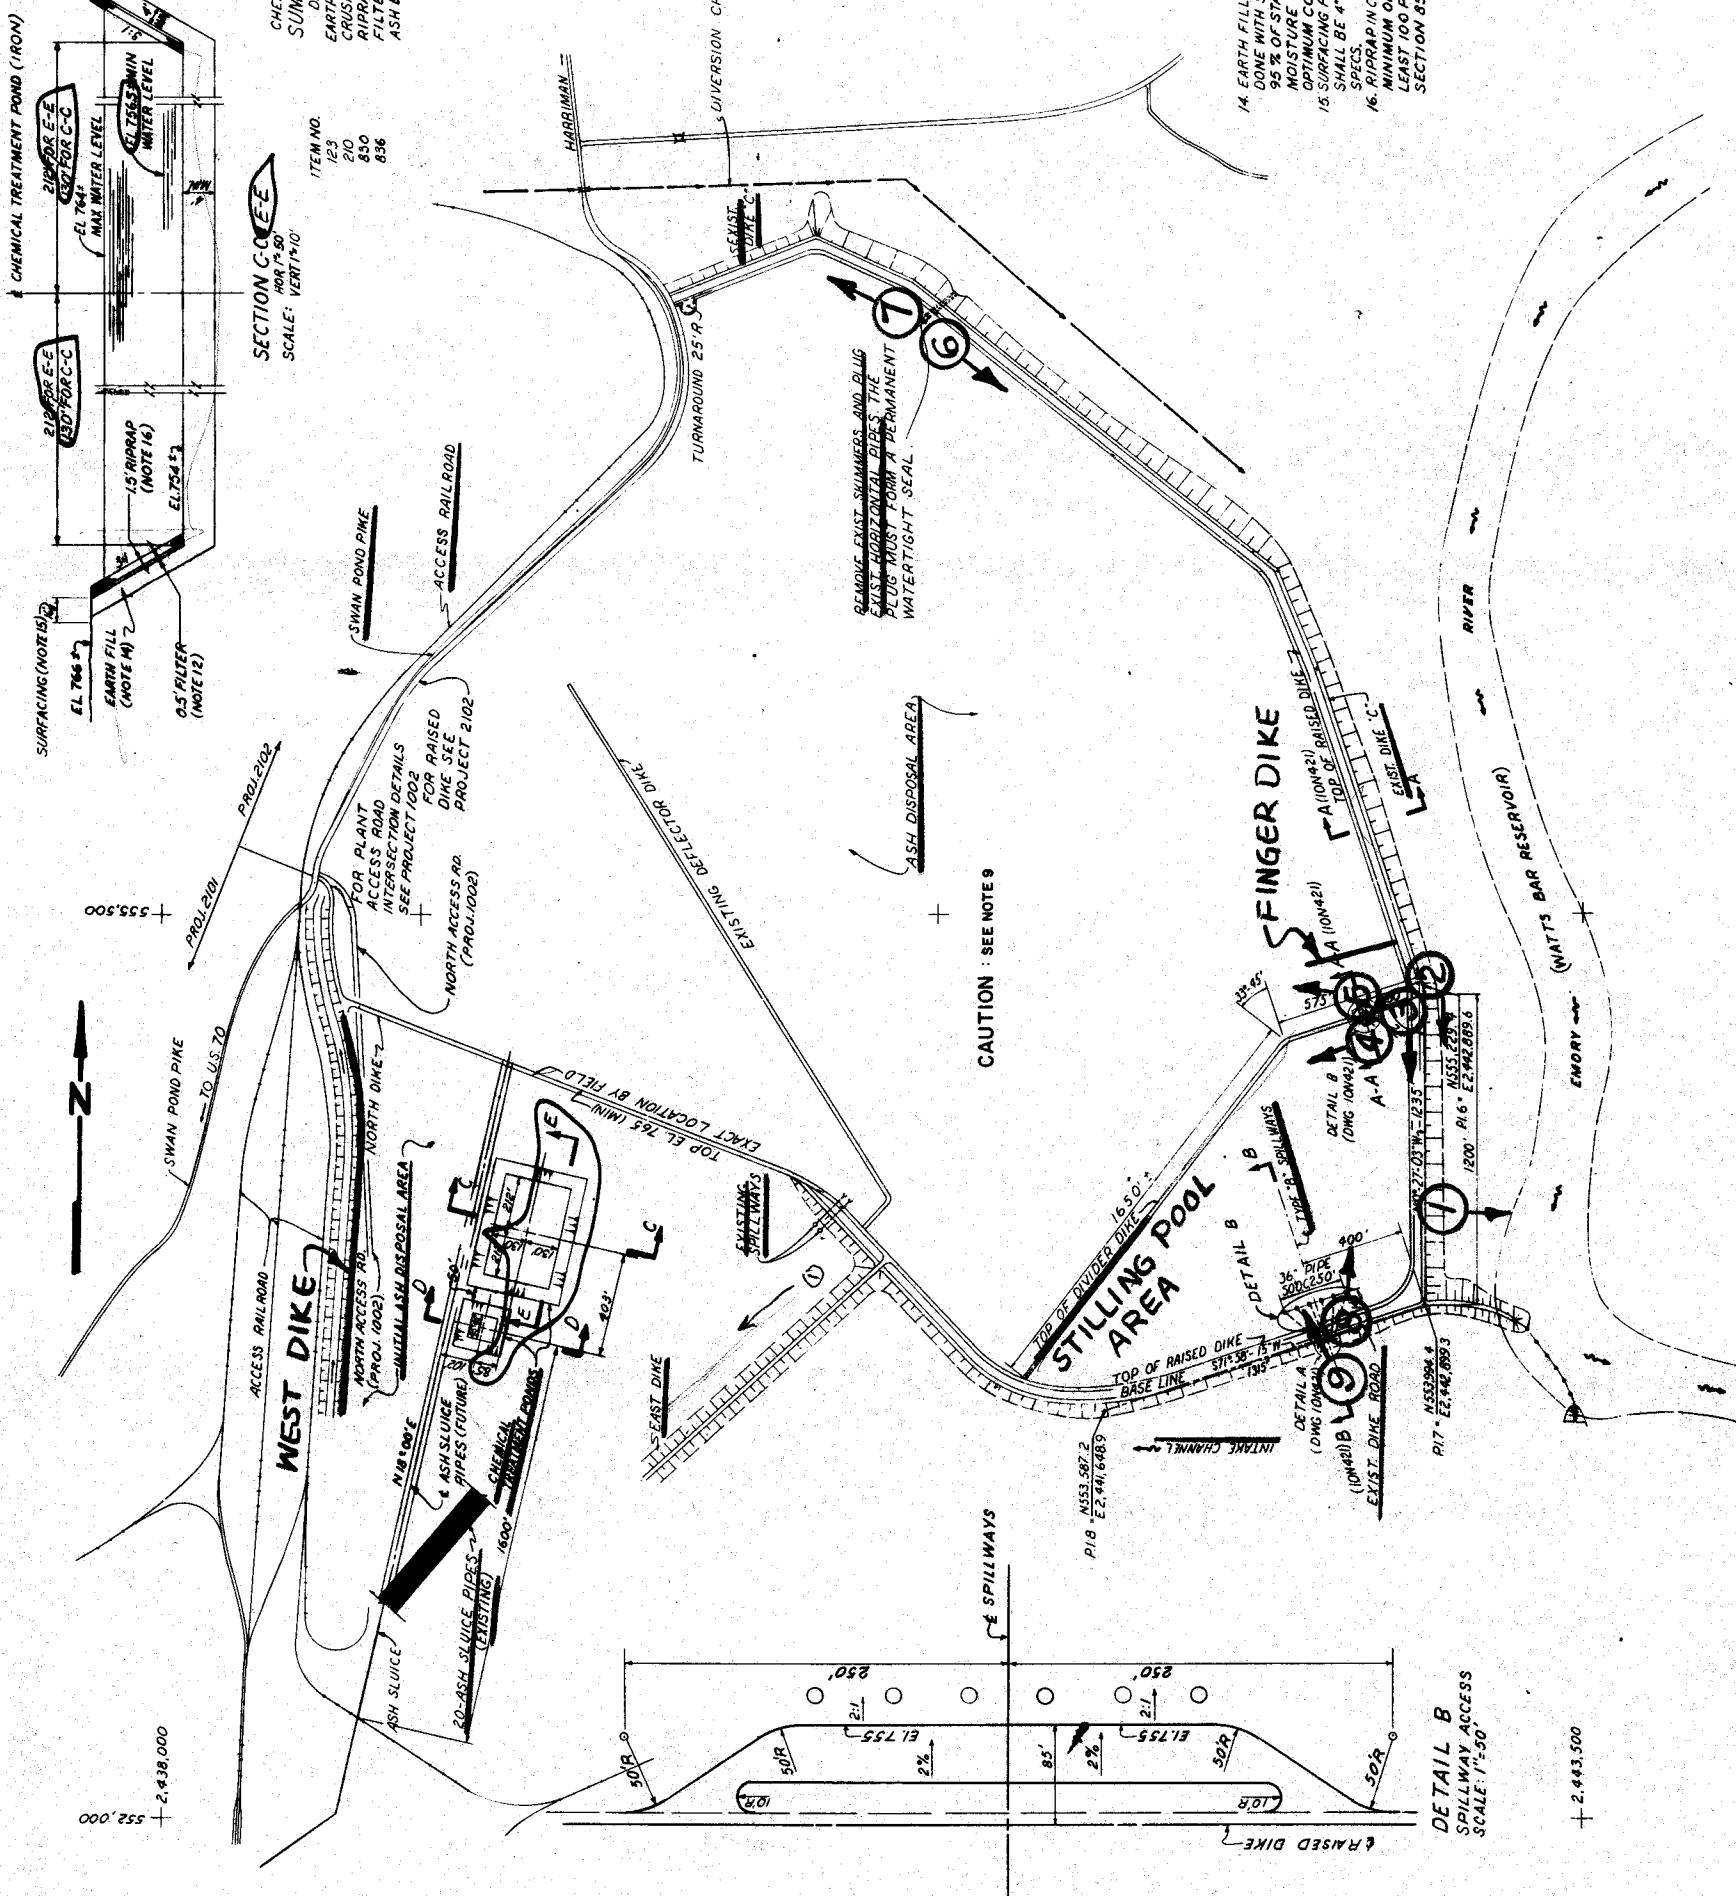
(9)

Some areas of the dike slopes, both interior and exterior, have an excellent vegetative cover (pictures 2 and 3); while other areas have a very sparse vegetative cover or are completely bare (pictures 6, 7, and 9 and recommendation 2). Small erosion gullies have developed in parts of the bare areas.

Looking into standard spillway outlets. Note absence of vegetative cover on dike slope above spillway outlets.
