2010 Annual Inspection of CCP Facilities and Ponds

Kingston Fossil Plant
Harriman, Tennessee

Prepared for:
Tennessee Valley Authority
Chattanooga, Tennessee

June 1, 2010

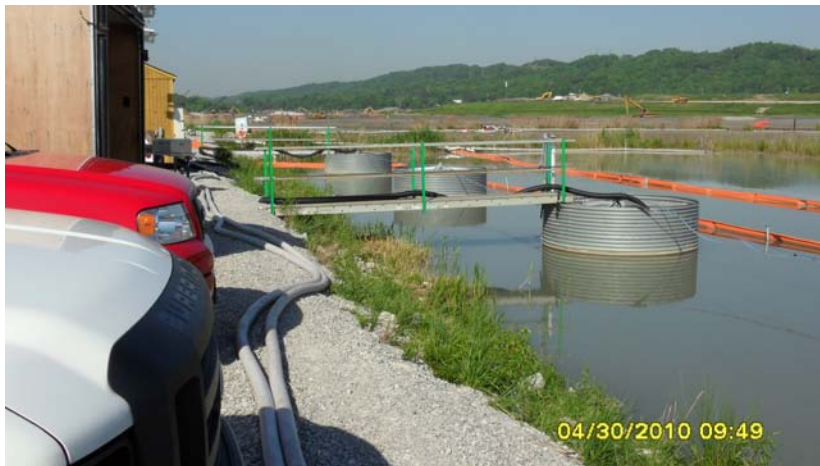
Photo 4

Trees and vegetation on Dike C alongside Intake Channel looking southeast.

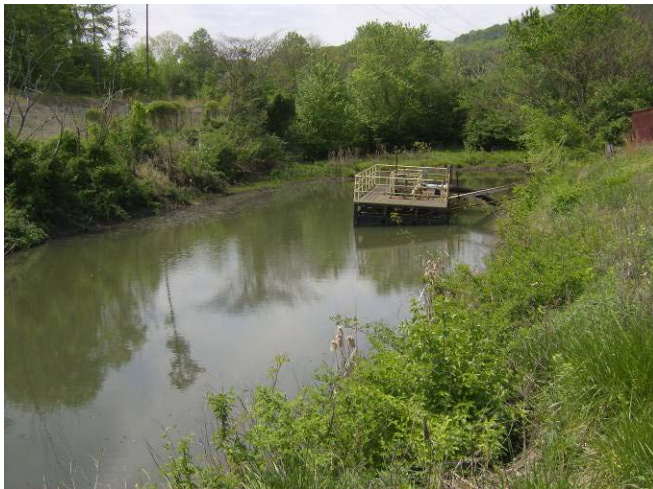
Photo 10

slopes (Photos 10 and 11).
Wave Wash Protection:	N/A
Erosion:	Severe localized erosion at inlet pipe on north embankment of pond. Soil eroded and undercut area approximately 10 feet by 3 feet (Photo 14).
Instabilities:	Slough several feet across observed immediately west of inlet erosion on pond embankment (Photo 15).
Animal Burrows:	None observed.
Freeboard:	Approximately 6 feet (estimated).
Encroachments:	None observed.
Slope:	Estimated at approximately 2H:1V.
4.2. Crest	
Crest Cover and Slope:	N/A
Erosion:	N/A
Alignment:	N/A
Settlement/Cracking:	N/A
Bare Spots/Rutting:	N/A
Width:	N/A
4.3. Exterior Slopes	
Vegetation:	N/A
Trees:	N/A
Erosion:	N/A
Instabilities:	N/A
Uniform Appearance:	N/A
Seepage:	N/A
Benches:	N/A
Foundation Drains, and	N/A

View of rock check dams from floating pump structure looking east. Trees and storm water outlet visible on south slope in upper right of photo.

- Trees and brush are located on the interior and exterior slopes. It is recommended that trees and brush be removed from these slopes in accordance with the general guidelines shown in Enclosure I. (Priority 4)

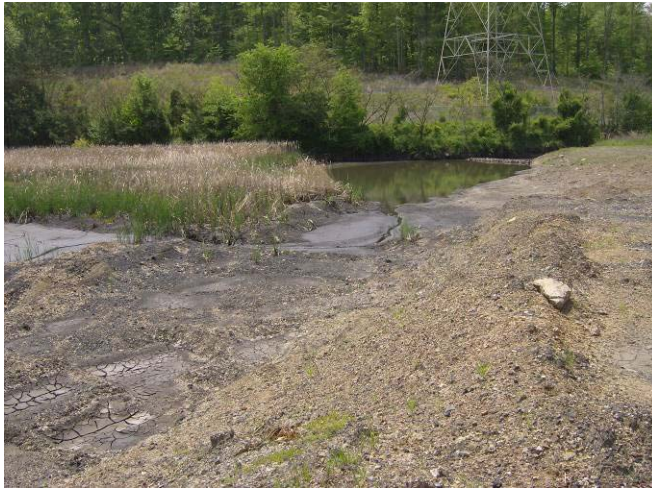
Photo 12

Settled material immediately east/northeast of coal yard drainage basin, looking southeast.

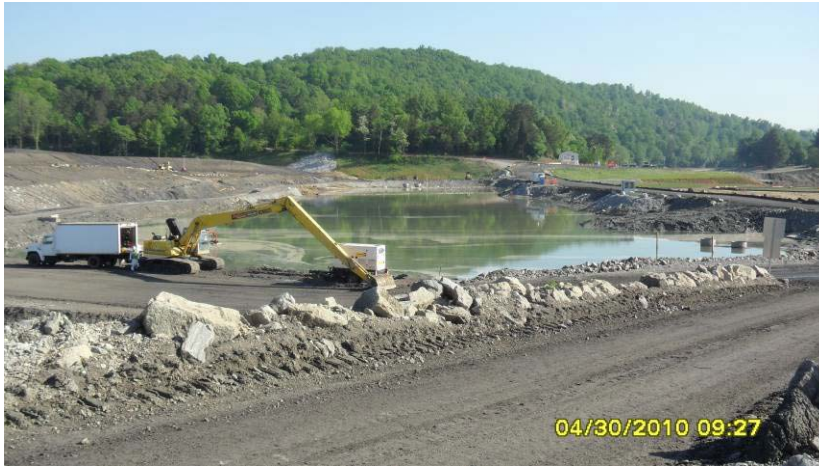
Photo 16

View looking north/northeast at Dike 2 sediment basin.

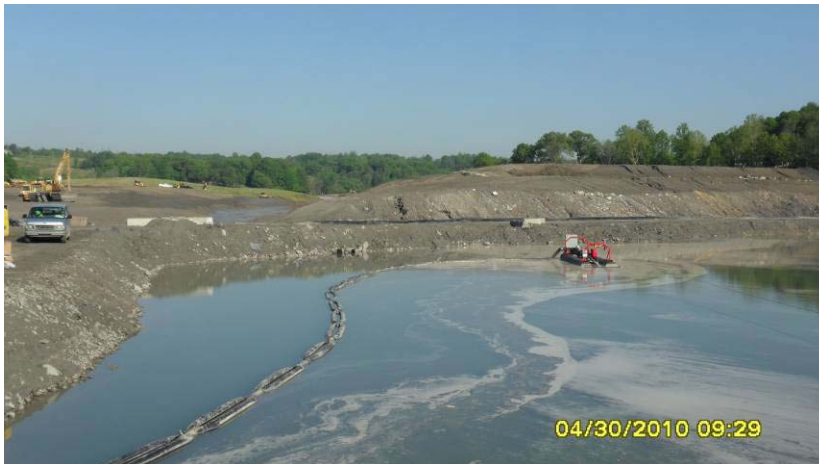
Photo 17

View of south end of sediment basin looking west, with floating pump attached to guy wire located in pond.

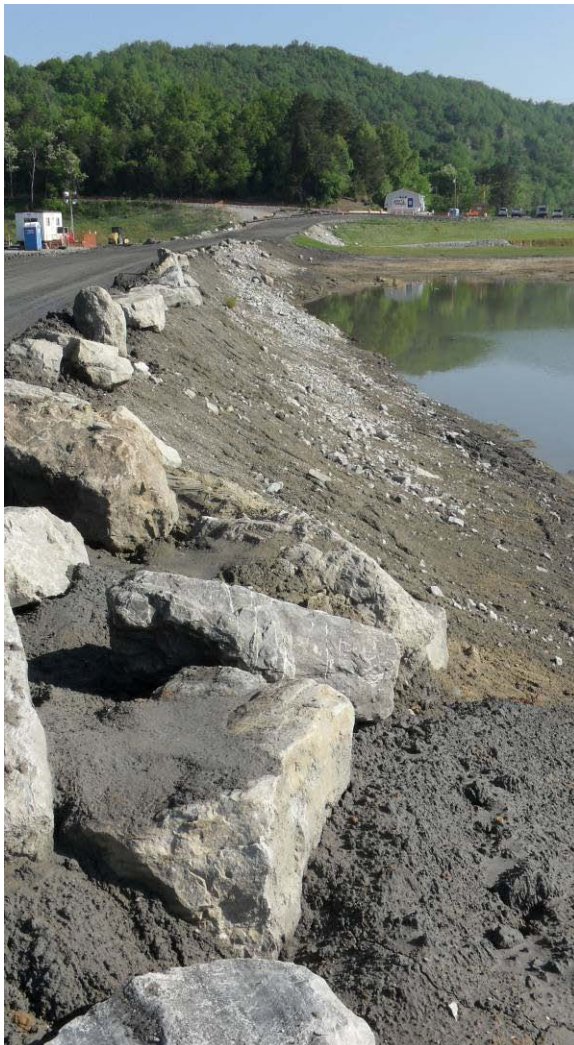
Photo 20

View looking north at extent of exterior Dike 2 slope.

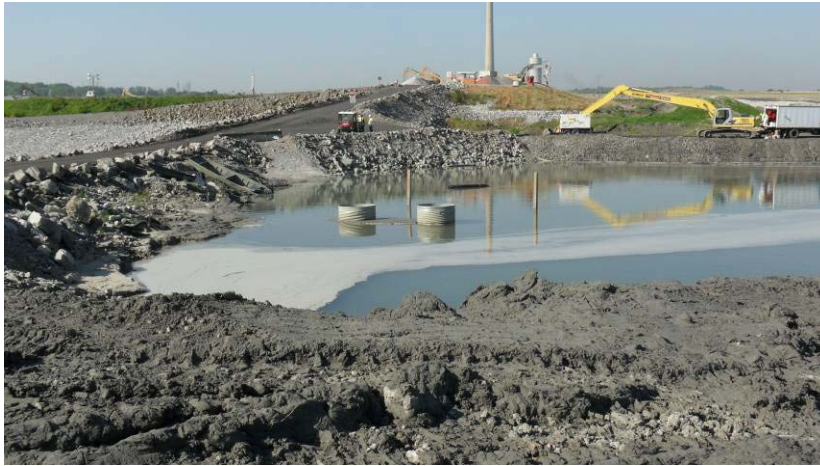
Photo 21

View looking south across sediment basin with 2 spillway inlets visible in center of photo.

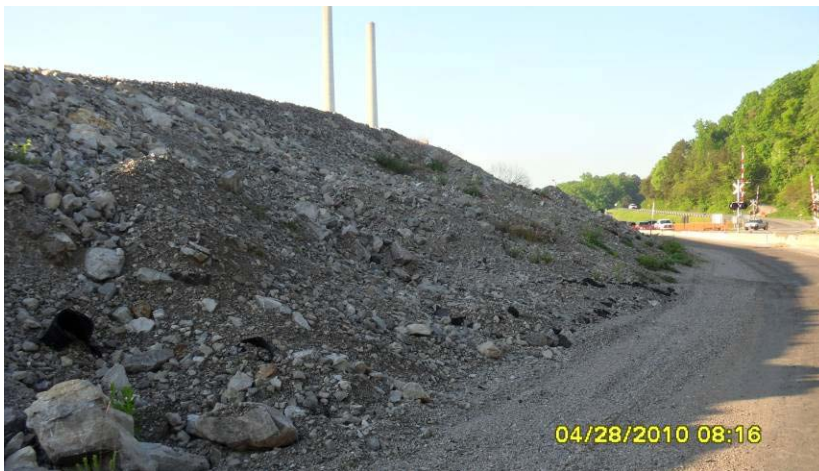
Photo 22

Shot rock haul road constructed on southwest corner of Dike C. Ponding water observed.

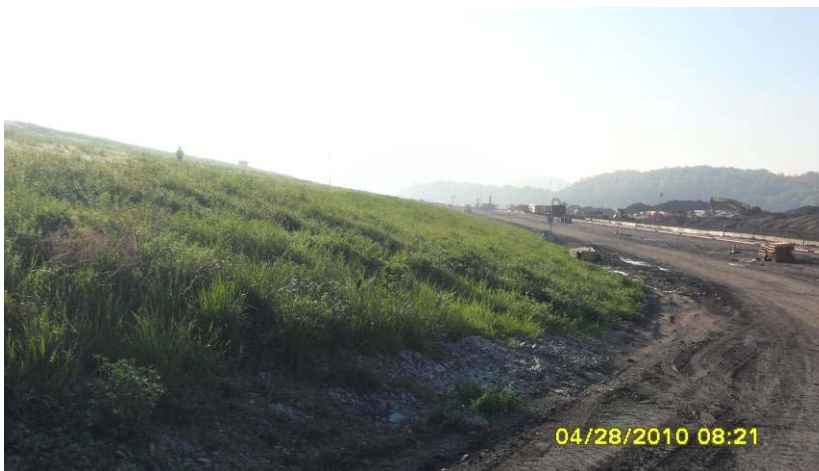
Photo 23

Shot rock built-up section of haul road at southwest corner of Dredge Cell, looking south.

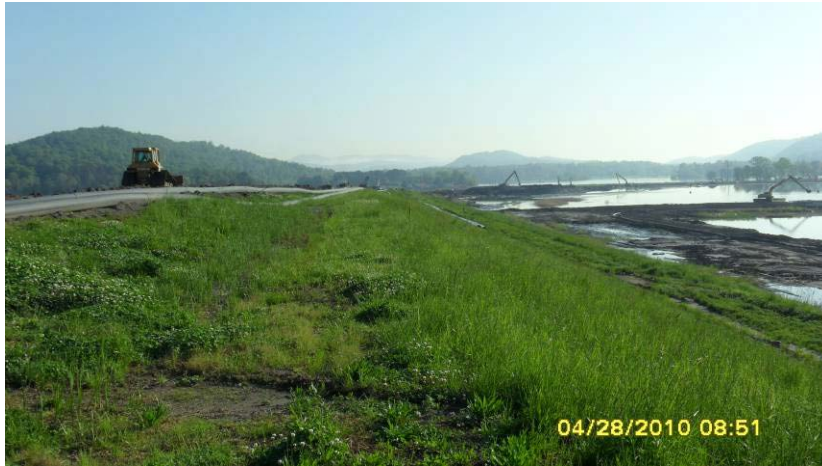
Photo 30

Typical ponding and rutting for Dike C on south side of Dredge Cell, looking east.

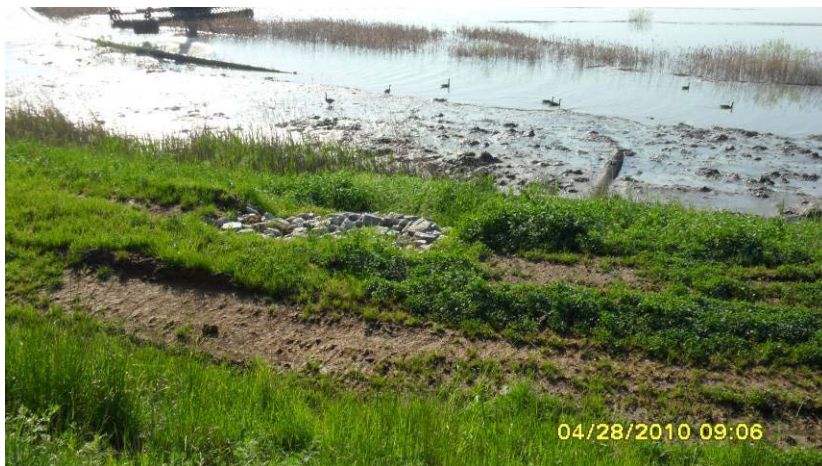
Photo 32

Minor erosion with additional vegetative cover required along Dike D.

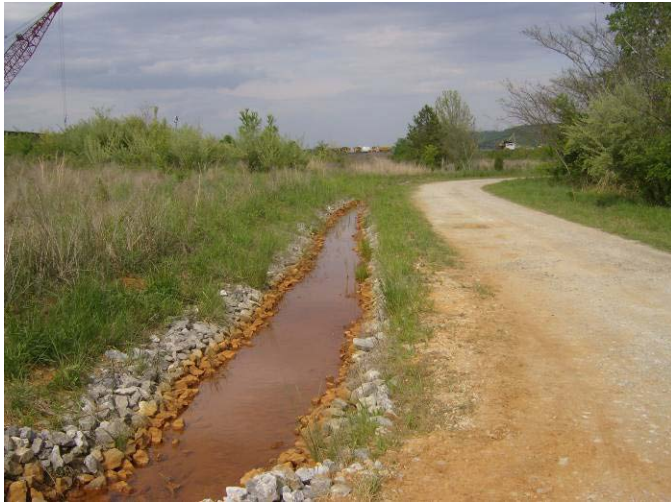
Photo 39

Redwater drainage ditch along west side of access roadway immediately west of Intake Channel, looking north.

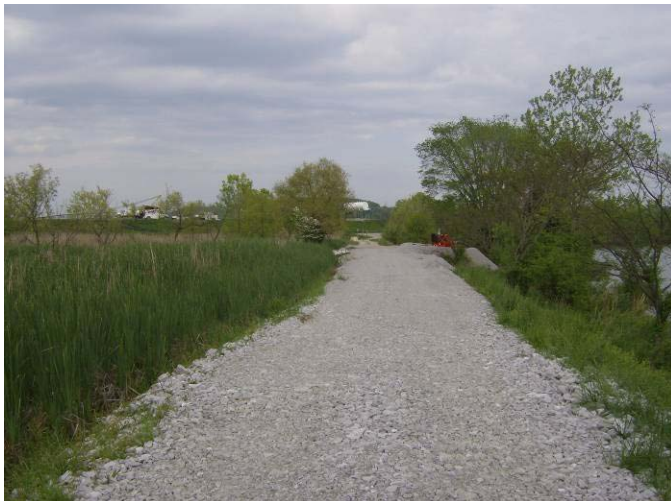
Photo 40

View of typical access road corridor along east side Engineered Redwater Wetlands, looking north.

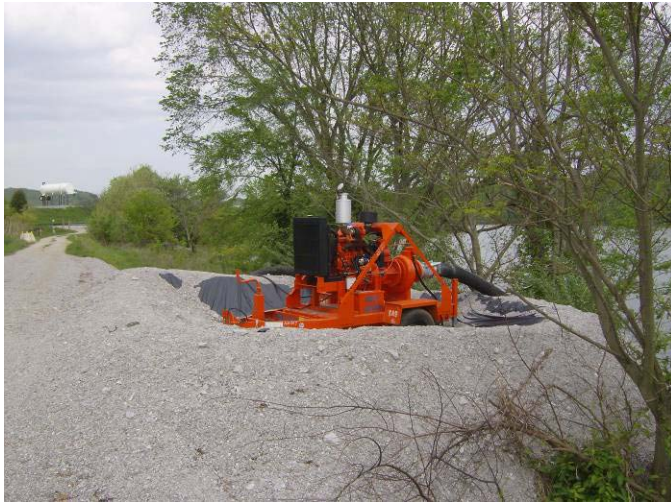
Photo 42

Discharge pump alongside shoreline of Intake Channel.

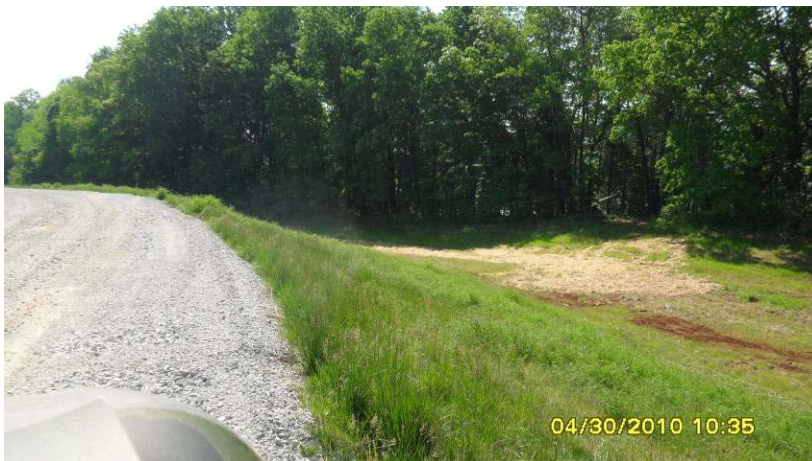
Photo 48

Vegetation:	Grass-covered, ranging from well covered to bare soil.
Trees:	Trees were not present on any of the slopes. However, numerous large trees lined the edge of the peninsula beyond the toe of the exterior slopes along the south (Photo 48).
Erosion:	None observed.
Instabilities:	None observed.
Uniform Appearance:	Yes.
Seepage:	None observed.
Benches:	None observed.
Foundation Drains, and Seepage Collection Systems:	None reported or observed.

Exterior slope on south side of gypsum pond with crushed stone access road at crest, looking southeast.

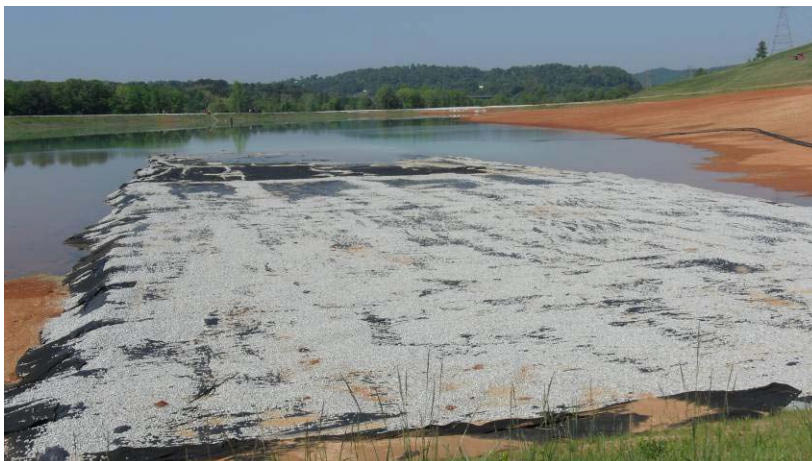
Photo 49

Drainage layer under construction on east side of Gypsum pond.

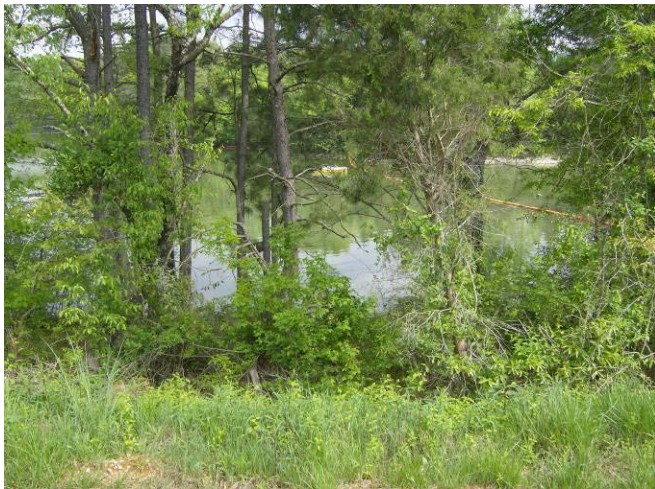
Photo 52

Typical view of thick vegetation and trees located along the Intake Channel, looking east.

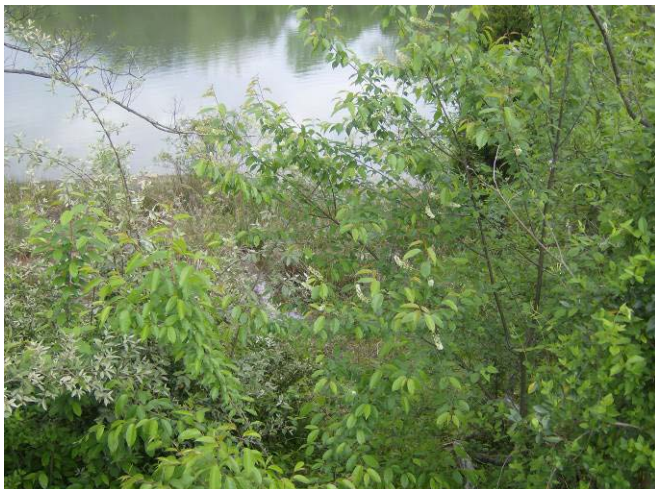
Photo 53

shoreline along the east dike.
Instabilities:	None observed.
Uniform Appearance:	Yes.
Seepage:	Seepage observed at multiple locations between the Sluice Trench and the Engineered Redwater Wetlands (Photos 53 and 54). Monitoring of the seeps and ongoing analysis being conducted by Geosyntec.
Benches:	N/A
Foundation Drains, and Seepage Collection Systems:	None reported or observed.
Instrumentation:	Six piezometers were installed by Mactec in April of 2010 along two cross sections of the east dike to monitor the current seepage conditions.
Animal Burrows:	None observed.
Slope:	Varies from approximately 4.25H:1V to 4.61H:1V. Slopes on the east dike varied from approximately 1.96H:1V to 3.36H:1V, flattening out to 5.23H:1V along the southern portion of the east dike.
Height:	19 feet

Seepage located along the Intake Channel.

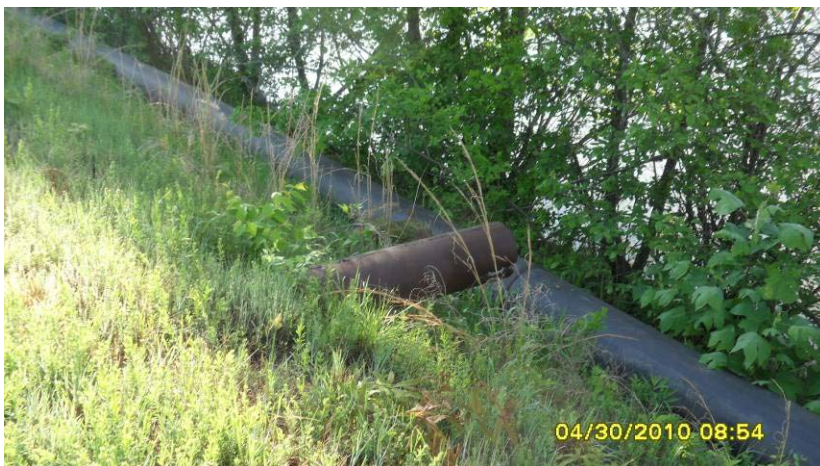
Photo 61

Overflow pipe to discharge into Intake Channel.

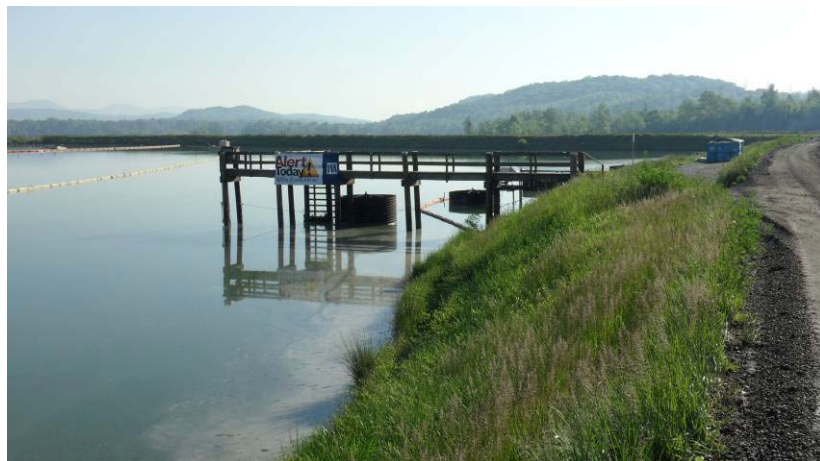
Photo 63

Number:	6
Size, Type and Material:	48-inch RCP push-together riser pipes with standard TVA steel skimmers.
Height of Riser Inlets:	Approximately 8.5 feet.
Access:	Catwalk from Dike C (Photo 63).
Joints:	Not observable.
Mis-Alignment:	Not observable.
Closed/Abandoned Conduits:	There is reportedly an unidentified 12-inch diameter pipe connected to weir -010 that penetrates the dike with no evidence of an outlet.

Catwalk access to spillways.

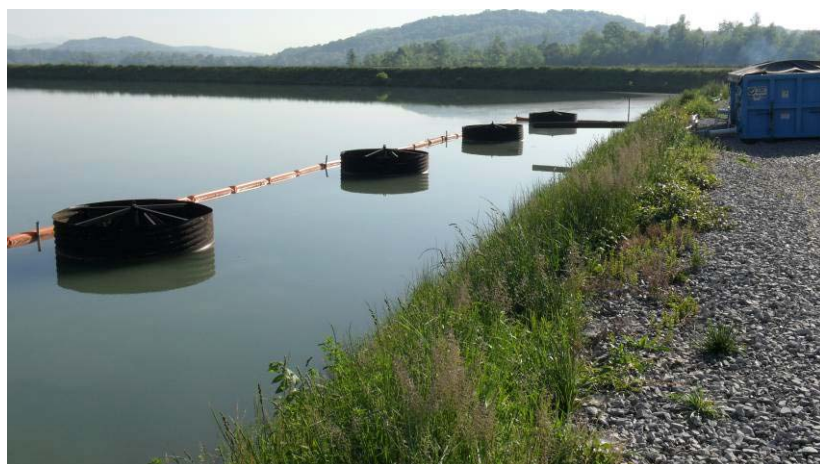
Photo 64

View of spillways looking northeast from Dike C.

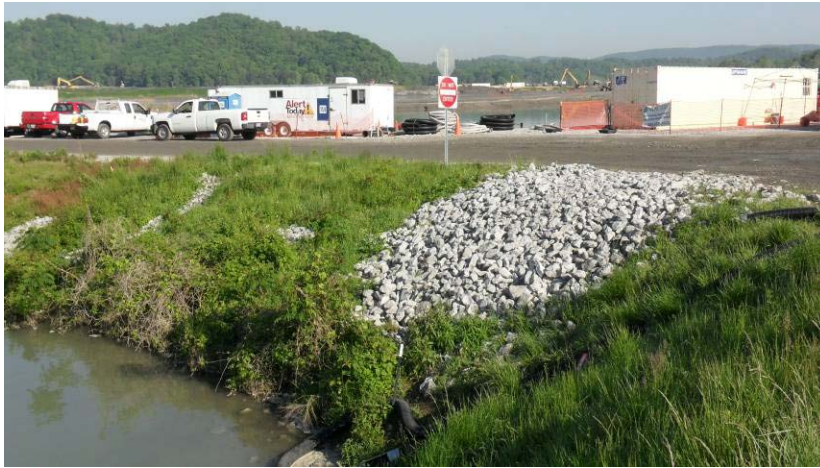
Photo 65

Slope protection at intersection of Dike C and Divider Dike in north corner of Stilling Pond; typical small trees present near waterline.
